TBY, INC
Karl Huffaker, P.E.
Krlhuff@aol.com
208-599-4189

December 23, 2013

The following report summarizes the inspection of the Tri City & Olympia Railroad Company (TCRY) branch mainline track for the Port of Benton. The track inspection was done during September 2013. The TCRY provided assistance during this inspection.

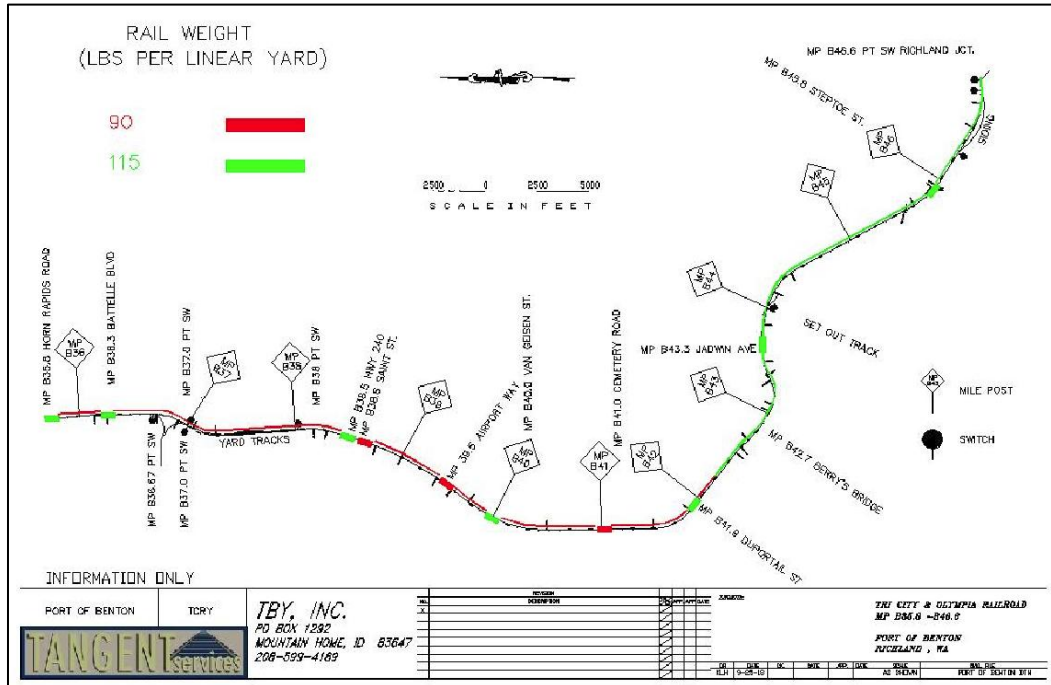
Figure 1: Rail Weight

- The entire track consists of combinations of 90# to 115# rail. 90# rail implies 90 lbs per linear yard of rail. Most rail lengths are 39 foot sections. Some of the higher weight rail near MP 44.3 is 78 foot sections. Current industry standards require at least 112# rail. All 90# and 115# existing rail is joint bolted together and staggered so joints on the left rail are not in the same location as joints on the right side rail.

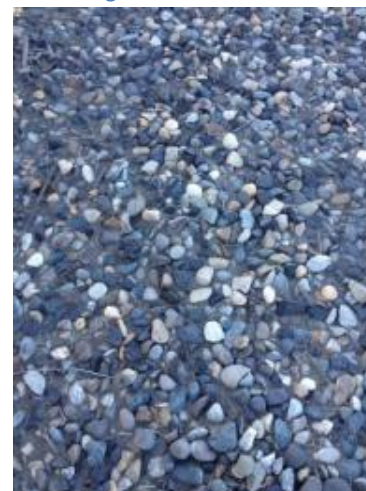
Figure 2: Ballast Rock

- Existing ballast is primarily smooth river rock (**Figure 2**). This type of rock does not meet standards for railroad construction. Although this type of ballast will usually stabilize a tangent (straight) section of the track without any problems, using this rock on curves will cause alignment problems during repeated train traffic operations and cold/hot temperature changes. Smooth rock does not have the interlocking (stabilizing) ability that fractured rock possesses. This is evident on the track between MP 41.9 & the Berry's Bridge (I-182 overpass) approximately 4000 track feet.

- Existing track maintenance noted in our inspection performed by TCRY consisted of tie replacement, removal of sand in yard tracks, some minor patching of asphalt at road crossings. Signal arms that had been damaged and replaced by TCRY, signal maintenance by TCRY signal sub contractor.
- Surfacing of the track with industry standard ballast should be scheduled as a long term project. This project will eventually “force out” the smooth river rock and replace with angular material. Track sections between MP B42 and Berry’s Bridge showed track movement laterally with rail temperature changes, creating tie shift. Ballast surfacing and track lining should be done in this area as noted below (**Table 2**).

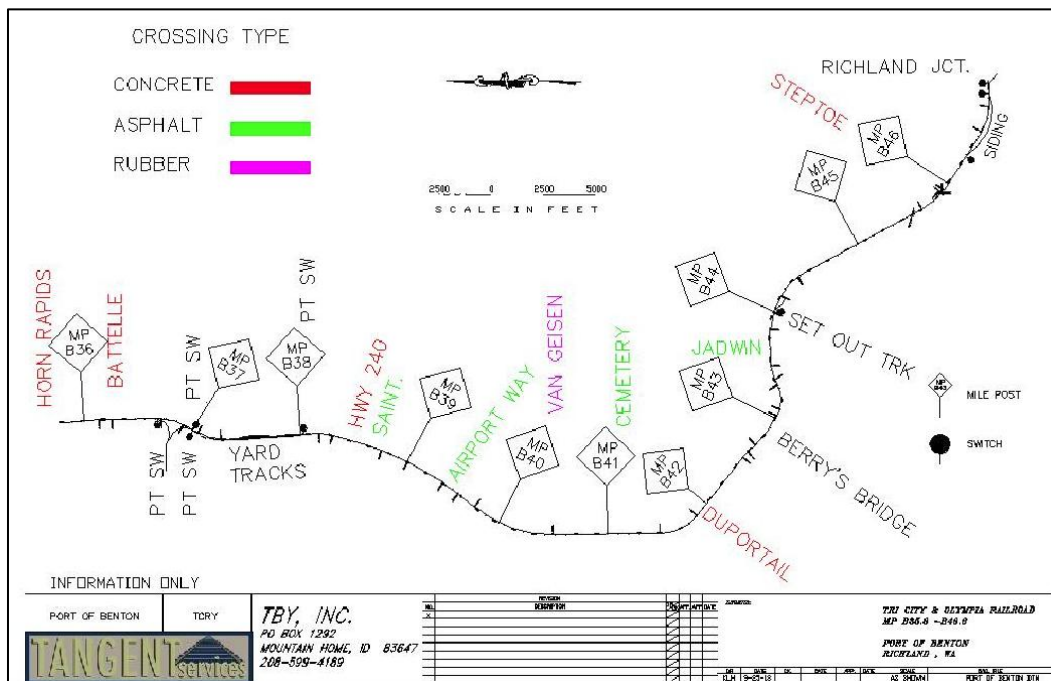
Figure 3: Crossing Type

- No visible drainage issues were observed on either side of the track.
- There are ten (10) major crossings on the track. Surface and length are shown below (Table 1). The locations of the crossings are shown on Figure 3.

No.	Name	Length	Signals	Surface
1	Horn Rapids	85	Yes	Concrete Panel
2	Battelle Blvd	90	Yes	Concrete Panel
3	Hwy 240	60	Yes	Concrete Panel
4	Saint St.	28	No	Asphalt
5	Airport Way	50	Yes	Asphalt
6	Van Giesen St	100	Yes	Rubber Panel
7	Cemetery Rd	40	Yes	Asphalt
8	Duportail St	55	Yes	Concrete Panel
9	Jadwin Ave.	28	Yes	Asphalt
10	Steptoe	115	Yes	Concrete Panel

- The existing asphalt crossing at Airport Way should be replaced with concrete panels per industry standards. This is a heavily used crossing and the existing asphalt and small rail are deteriorating. An FRA rail defect was noted on the north side of the crossing. The estimated cost to replace with concrete panels is \$1000 per foot.

- Highway 240 is also heavily used. The concrete panels are deteriorating, and there is no drainage away from the crossing. The rubber seal gaskets are sliding to either side of the crossing, allowing foreign material to infiltrate the underside of the concrete panels.
- The T-Core (rubber) crossing at Van Geisen is deteriorating. This crossing should also be updated to concrete.
- The Tangent Services report of December 2012 offers additional discussion of the major crossings.
