# **Southern Connection – POB Industrial Rail Spur Rail Maintenance Cost Study C2024-12**

**Jeffrey Guelker  
JCG Consulting**

**5/3/2024**

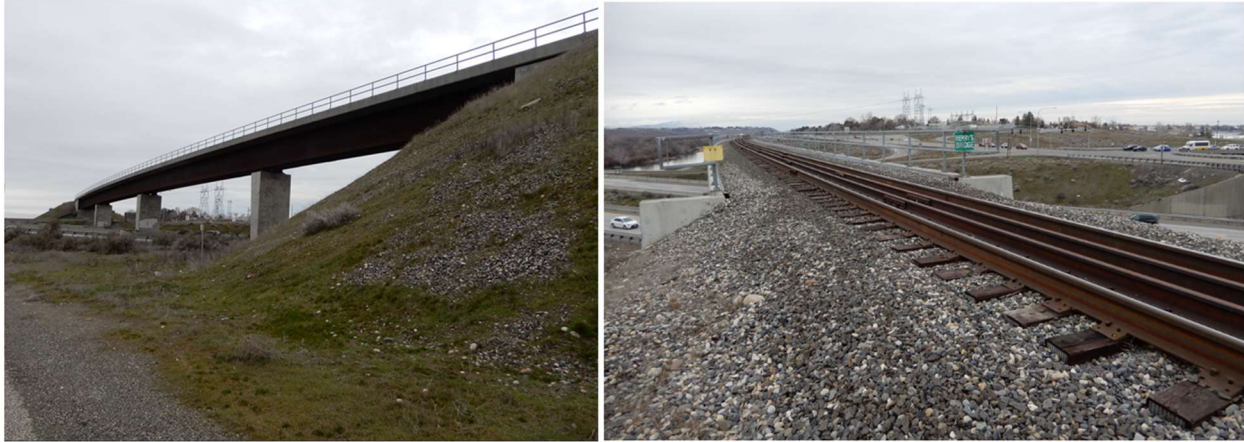
**Exhibit A.5**

Highlighting a location of mild concern to keep a watchful eye on. When the head end of a loaded grain unit train is traversing Berry's Bridge the train consist is spread across five curve sections of track, with as much as 4.8 degrees of curvature, with the rear end of the unit train still south of the City Dock. (Exhibit A.5)

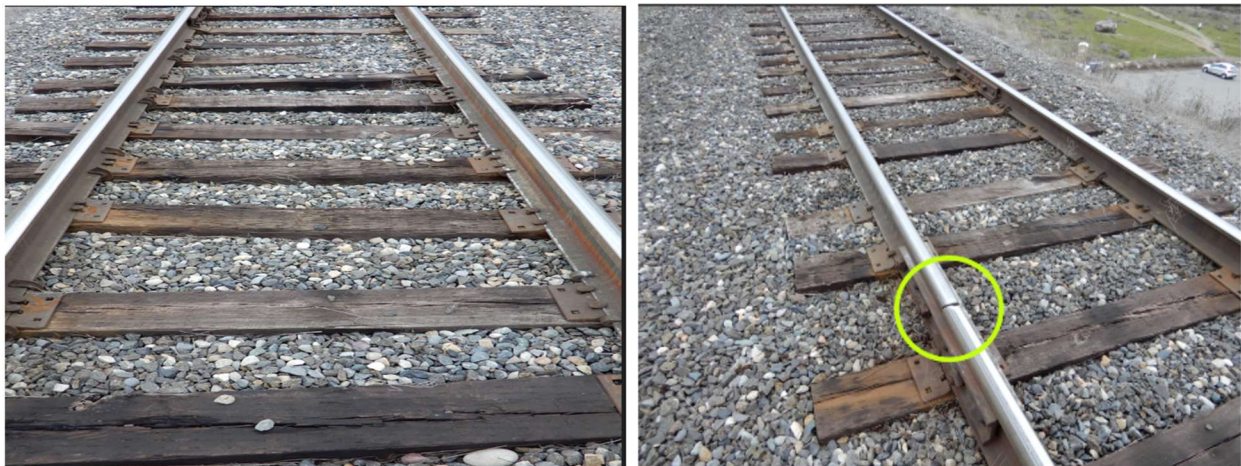
**Exhibit A.7**

Some marginal / fair ties and a damaged corner of rail at the joint prior to Berry's Bridge can be seen in Exhibit A.7.

While most of the rail in this span of track is 115lb, ongoing frequent inspections are recommended until said time that

- defective tie replacements can occur
- and the rail weight can be upgraded to 136lbs.

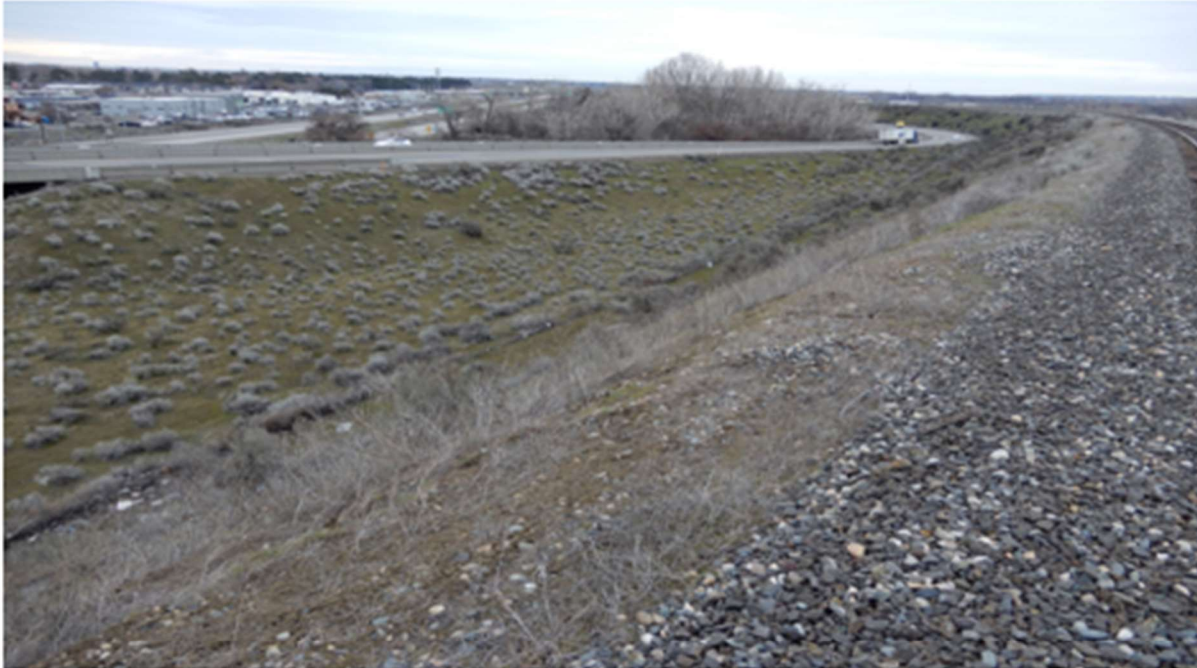
**Exhibit A.8**

Trains traversing Berry's Bridge are at a moderate elevation above the ground crossing over a high traffic city street as seen in Exhibit A.5 and A.8.

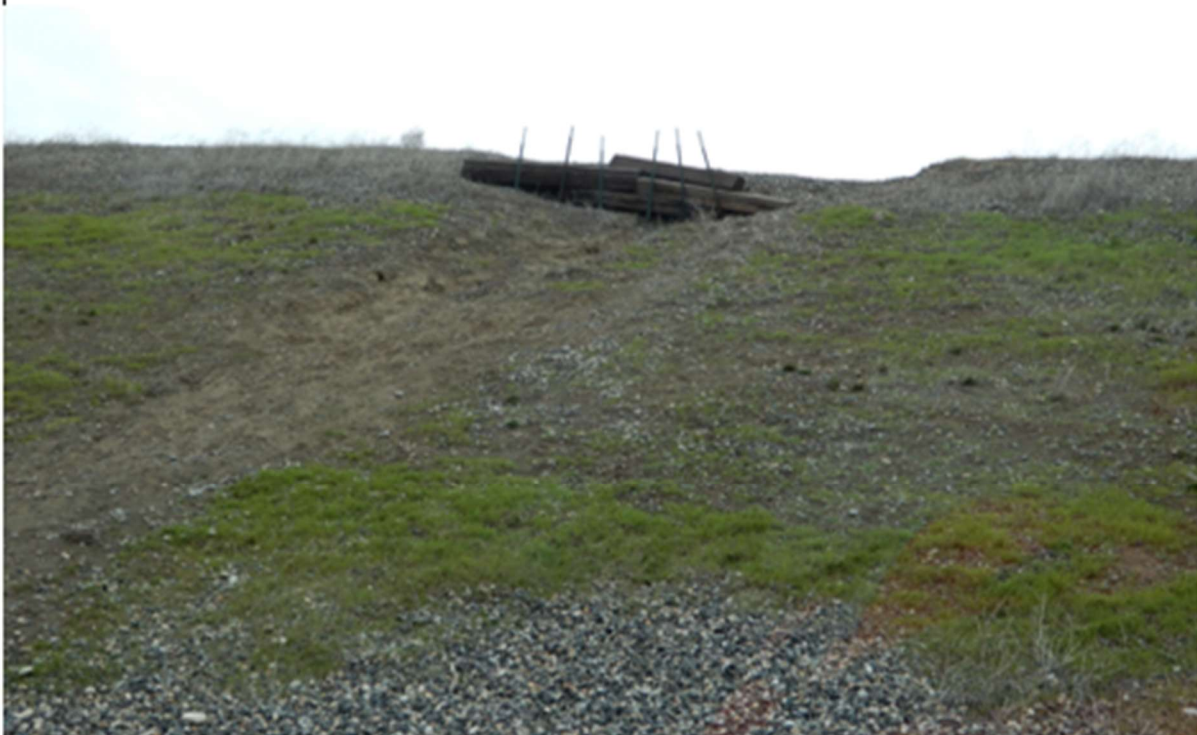
**Exhibit A.9**

There has also been some erosion of the hill overtime with a barrier erected to prevent further earth movement as seen in Exhibit A.9.

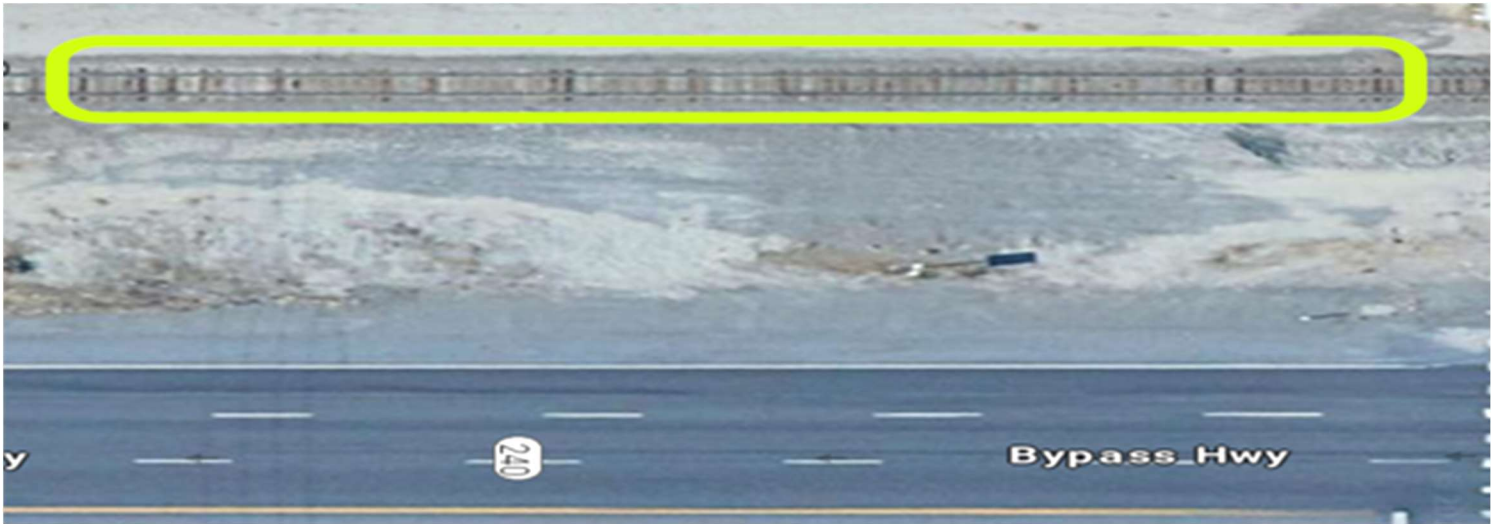
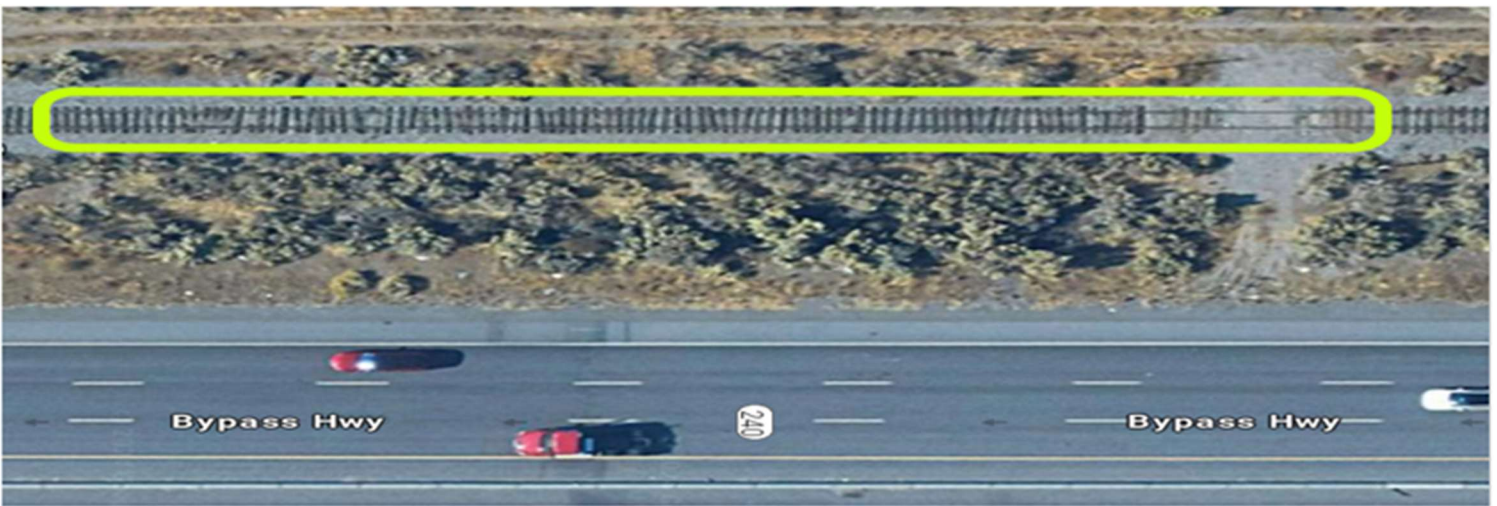
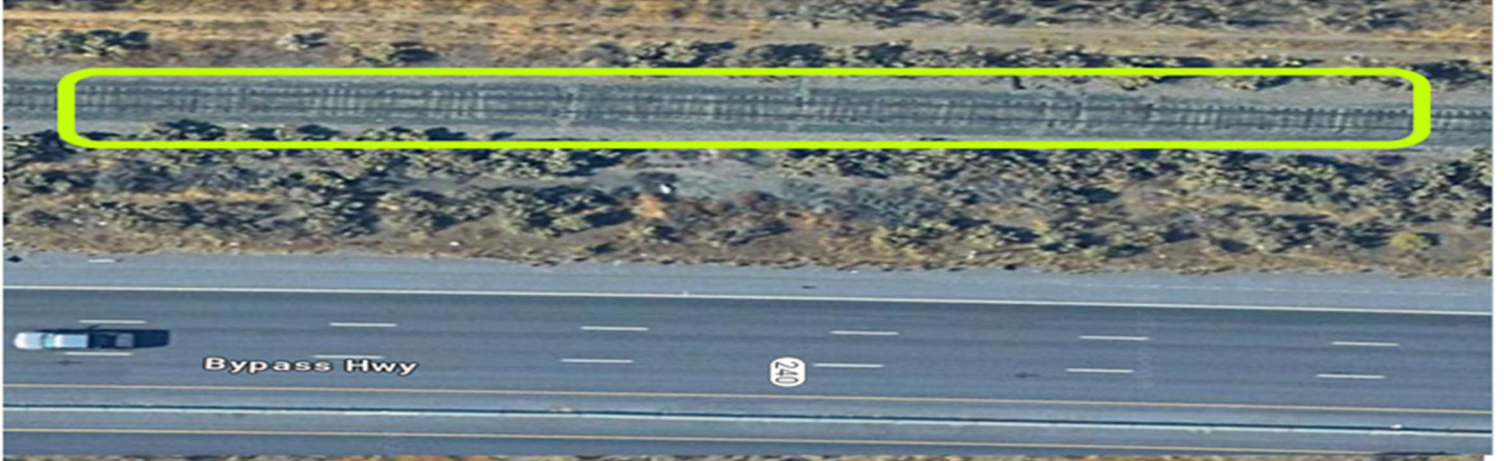
A multitude of photographs have been taken (shared), not only by JCG Consulting, over time showing the deteriorated condition of Richland’s railroad track infrastructure. For purposes of this assessment, I will highlight critical aspects of the current state while not belaboring the point since the infrastructure’s degradation is well known. Exhibit A10, A.11, and A.12 provide an aerial perspective (sourced from Google Earth) of the track traveling northbound along Hwy 240. Starting with Exhibit A.10, the railroad ties are no longer resting on top of the ballast but are buried underneath the ballast, and more concerning dirt, and mud. Exhibit A.11 depicts both uneven tie spacing as well as the non-parallel placement of railroad ties as they have shifted over time from railcar weight, the elements of nature, and historic lack of maintenance. The ties form a zig-zag type pattern (Z shape) leading to uneven weight distribution under the load of a train consist in transit. Exhibit A.12 shows the combination of both buried ties and tie shifting producing a double hit to the 90lb rail and its supporting roadbed comprised of ties, ballast, and fasteners. The impact of poor infrastructure along with smaller pound rail in curves is decreasing the potential lifespan of infrastructure components while increasing the possibility of a derailment(s).

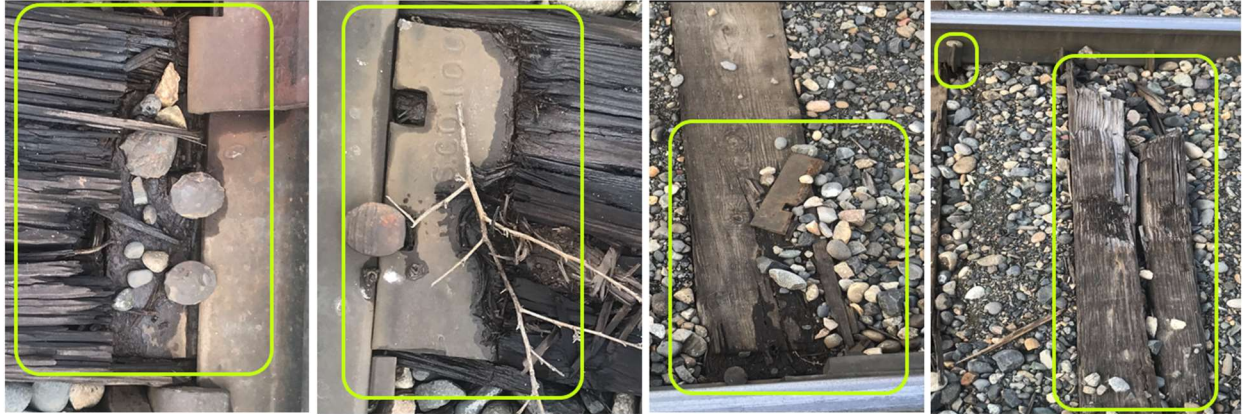
**Exhibit A.14**

Exhibit A.14: Poor ballast drainage resulting from non-elevated railbeds and the buildup (and subsequent elimination) of dirt and mud overtime has led to railroad ties that are shattering into toothpick fragments, tie plates that are cutting into the railroad ties, tie plates that are no longer attached to the railroad ties, broken tie plates, spikes that are no longer holding down the rail, and railroad ties that have completely rotted and are no longer a functional component of the actual railroad infrastructure.

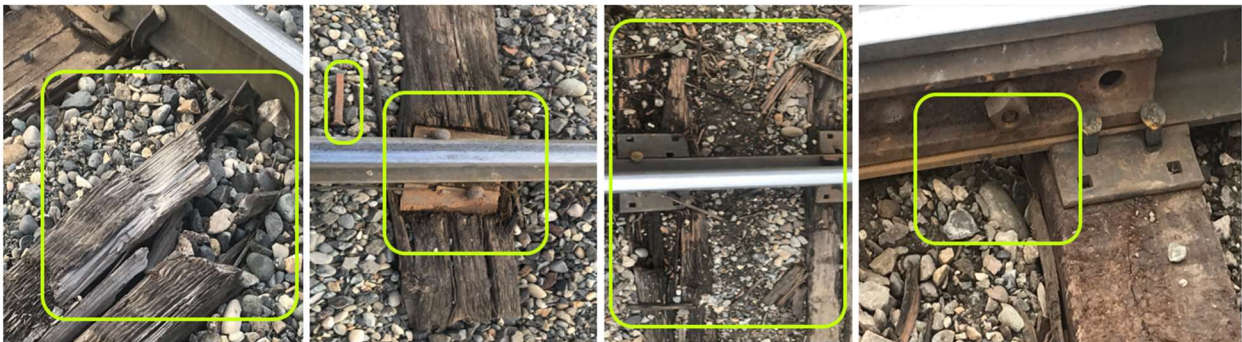
**Exhibit A.15**

Exhibit A.15 shows more examples of rotting wood damage, tie plates that are no longer functioning as intended, railroad spikes that no longer are serving as track fasteners, and gaps underneath elevated rail resting on top of ties with poor adjacent ballast coverage.

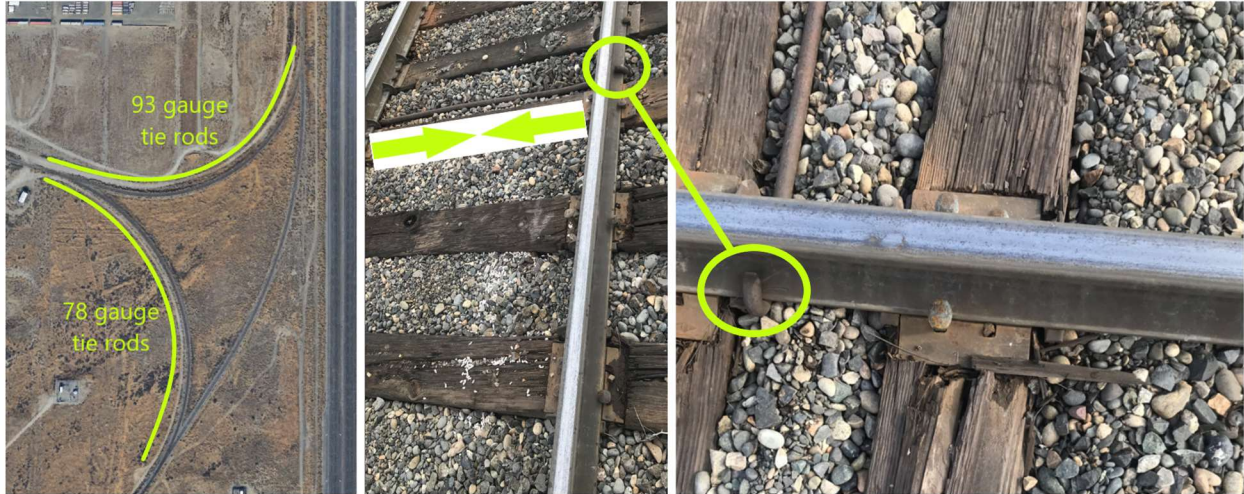
**Exhibit A.16**

As shown in Exhibit A.16, poor fastening of the rail to ties is causing rail gauge defects (improper separation between the left and right sides of the rail to match the wheelbase of the train consist). This results in unbalanced downward force (weight) further reducing the potential lifespan of the infrastructure components. Gauge rods have been installed all throughout the POB's track (especially curves) to help maintain the proper left to right rail spacing by eliminating spreading as well as preventing tilt. On the north and south wye's starting at milepost W28.90, 93 gauge tie rods have been installed in the northern section of the wye and 78 gauge tie rods have been installed in the southern section of the wye. The southern wye experiences heavy unit train traffic with substantial inward force produced by 8,000 ft trains whose mechanical preference is to move in a straight line. The northern wye experiences a similar number of total railcars traversing over the railcar however substantially higher total wear and tear force as the northern wye is used by both Class 1 railroads for switching smaller cuts of cars into the City Track customers, single car orders into the cattle feed loop track, and building the outbound cut of cars headed back south to the Class I's manifest yards.

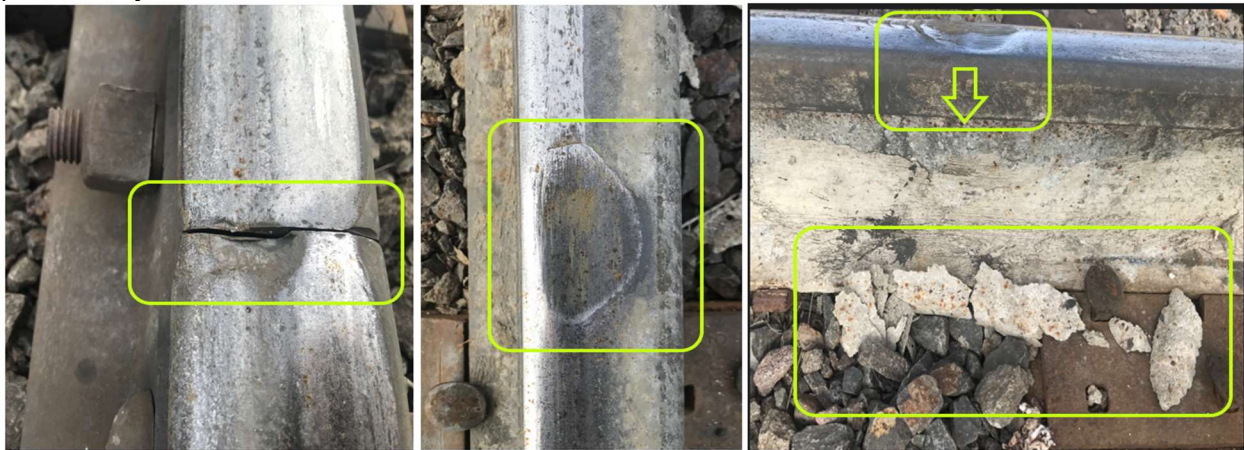
**Exhibit A.17**

The pictures in exhibit A.17 show operating damage to the 136lb rail infrastructure on the southern wye just north of the railyard. Nine areas of rail burn were observed on this track segment presumably due to one or both of the following operating scenarios:

- the elevated climb pulling 110 car unit trains out of Central Washington Corn Processors (CWCP) facility
- combined with improper locomotive servicing prior to spotting / pulling Richland rail customers.

Little to no sand, which is used to provide traction for locomotive wheels slipping while under load, was observed near the areas of rail burn. The photo on the right shows the downward force impact of the locomotive wheel being significant enough to break the concrete lime free from its long life “near permanently attached with the rail”.

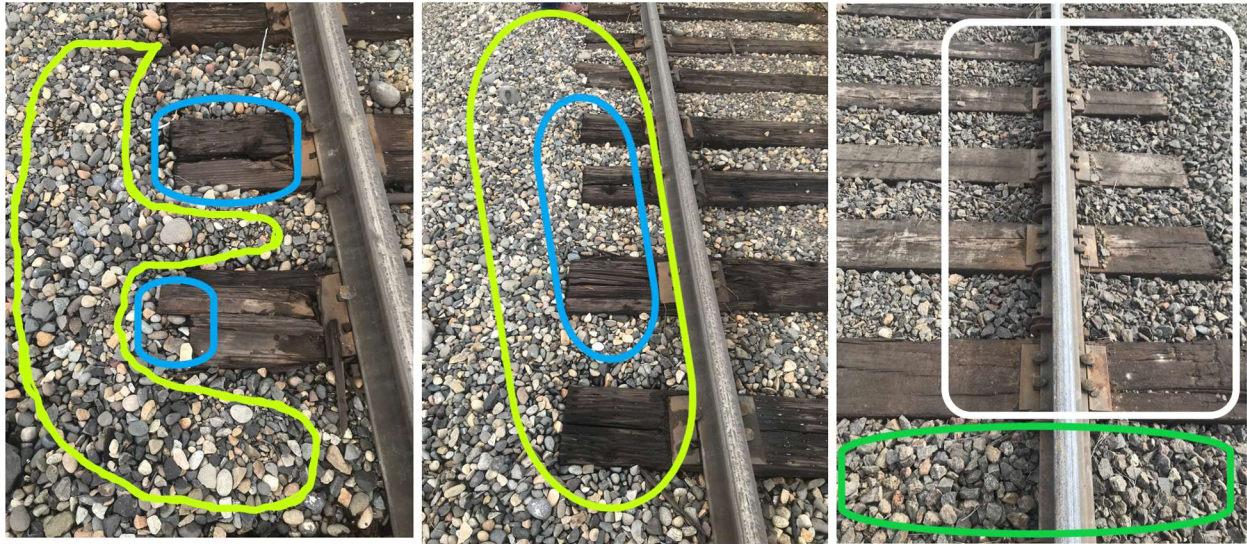
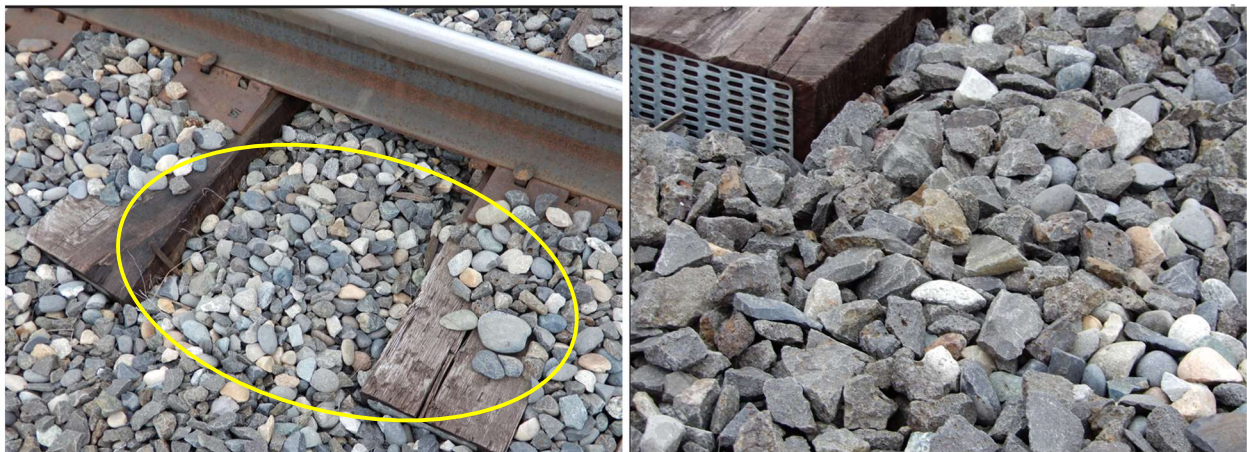
Exhibit A.18 & A.19. Round river rock (highlighted in yellow) found throughout the ballast roadbed of the POB track, has been shown to inhibit the flow of water and dirt drainage, whereby leading to the buildup of mud and eventually rotting ties (highlighted in blue). More angular non uniform types of ballast rock within the green ellipse in the rightmost picture, has been shown to provide much better drainage properties resulting in reduction of soil and mud buildup whereby elongating tie life, as identified inside the white box.

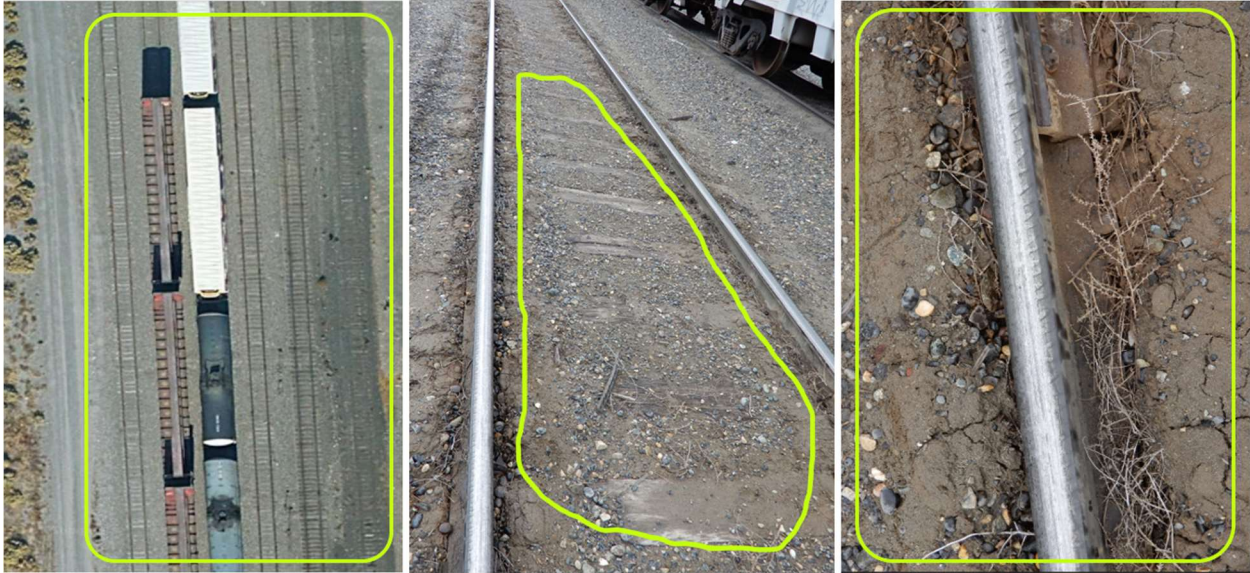
**Exhibit A.26**

Photos in Exhibit A.26 below and Appendix Exhibits A.2.15, A.2.23, and A.2.24 highlight the overall condition of the track infrastructure within the yard being poor with tie conditions worse than several sections of the mainline. A massive buildup covering the tracks is deteriorating the track bed and its support of the rail riding on top exponentially.

Exhibit A.26 provides an aerial and ground perspective of Richland’s railyard. Analogous to sections of the main line, railroad ties are buried underneath mud and round gravel. Visible railroad ties can be categorized as undergoing various states of rotting, while a considerable number of ties are completely buried under mud and unable to be adequately inspected.

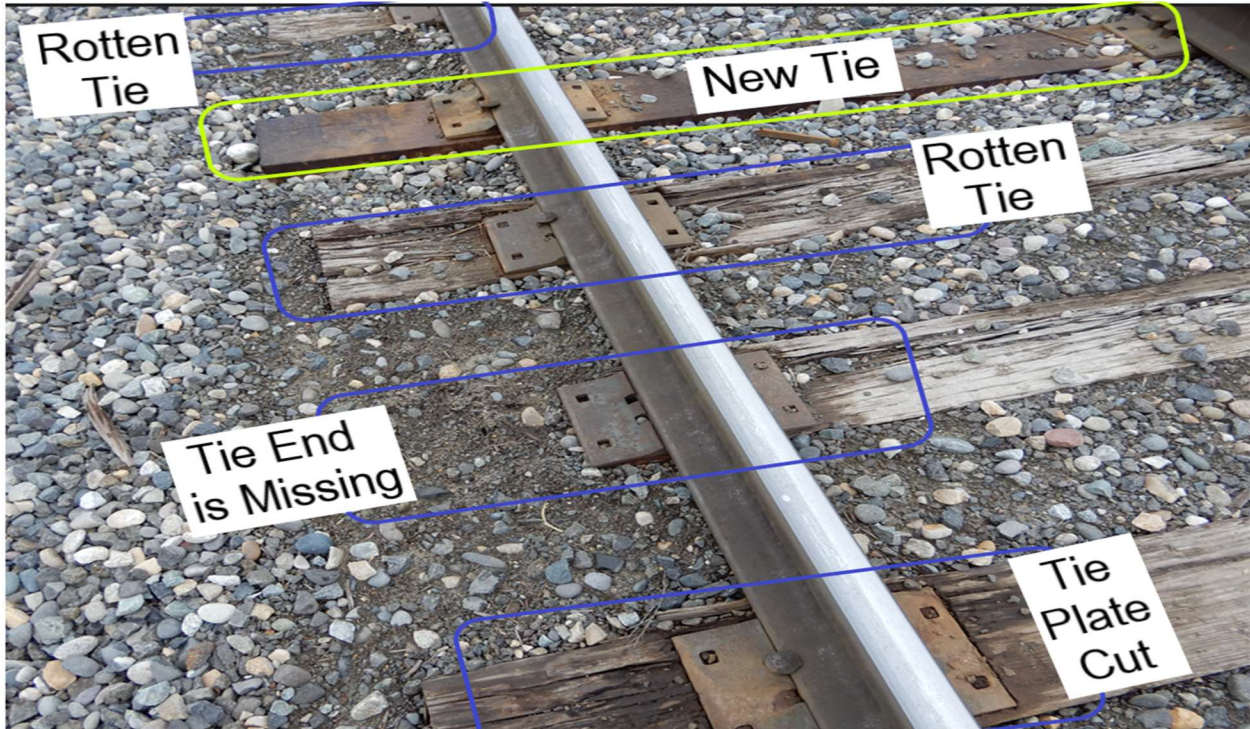
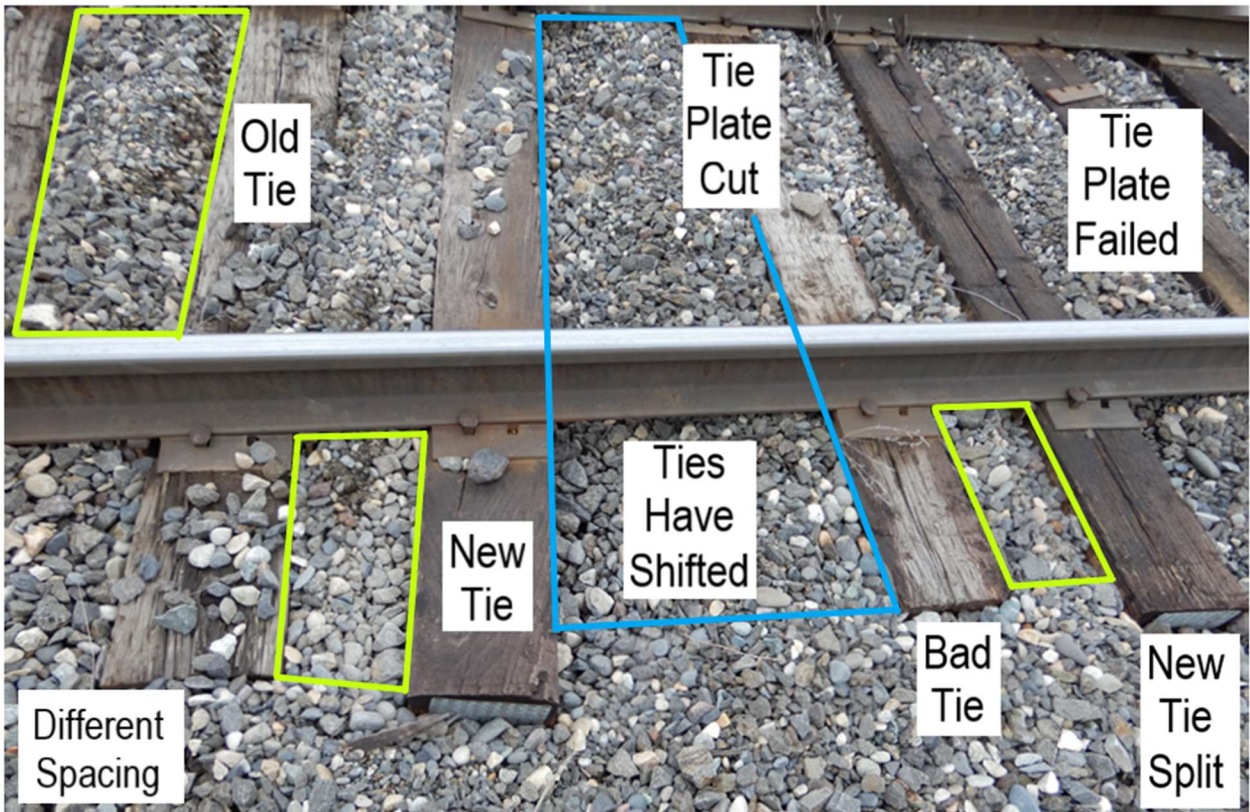
Consider the following pictures (Exhibits H.8 and H.9) taken during the February site visit. New ties have been installed next to defective (rotting) ties. The downward force on the new tie is no longer 27% as indicated in Exhibit H.3. The highly probable prediction for these brand new ties is a lifespan much less than 40 years which equates to more frequent replacement equating to a higher per car charge necessary for the POB to cover future maintenance costs.

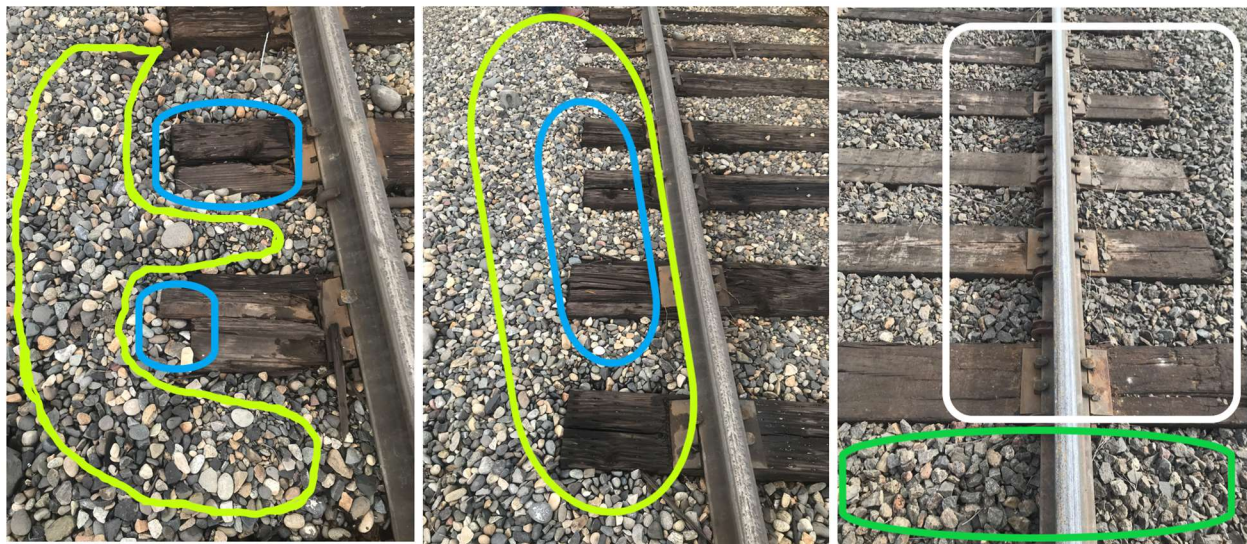
**Exhibit H.10**

(Exhibit H.10.) Round river rock (highlighted in yellow) found throughout the ballast roadbed of the POB track, has been shown to inhibit the flow of water and dirt drainage, whereby leading to the buildup of mud and eventually rotting ties (highlighted in blue). More angular non uniform types of ballast rock within the green ellipse in the rightmost picture, has been shown to provide much better drainage properties resulting in reduction of soil and mud buildup whereby elongating tie life, as identified inside the white ellipse.
