2021 ANNUAL BRIDGE INSPECTION

Tri-City Railroad 1st Subdivision

Tri-City Railroad Company, LLC

2021 ANNUAL BRIDGE INSPECTION TRI-CITY RAILROAD COMPANY, LLC (TCRY) 1st SUBDIVISION

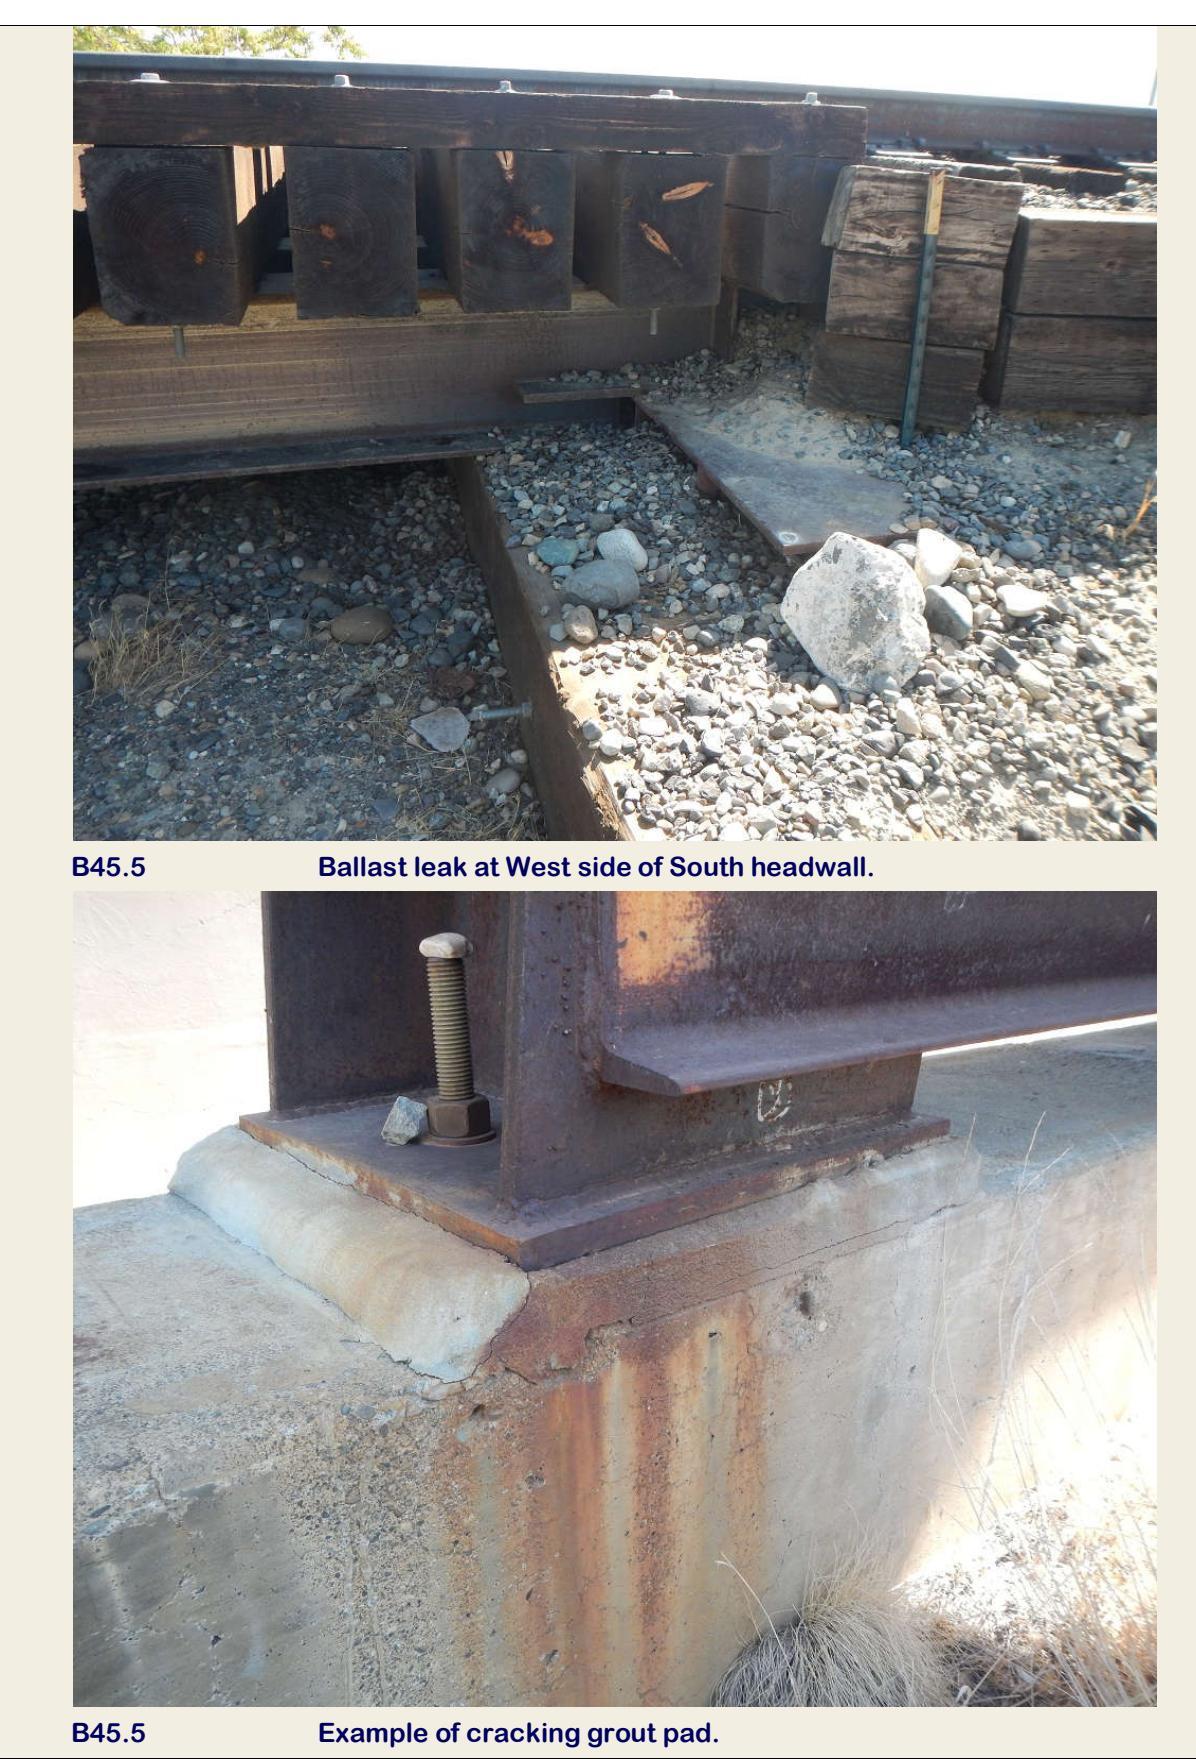
B45.5

Pier	Date	Hgt	Description	Pier Notes
I	07/16/21	-	Steel Cap on four steel H-Piles. This part of original approach.	Ballast leak on left side.
2	07/16/21	18	4-column steel bent. New 2015.	New in 2015 but grout pads performing poorly. Cracking and spalling noted in previous reports. Cosmetic repairs using grout attempted since 2018 inspection.
3	07/16/21	18	4-column steel bent. New 2015.	New in 2015 but grout pads performing poorly. Cracking and spalling noted in previous reports. Cosmetic repairs using grout attempted since 2018 inspection.
4	07/16/21	18	4-column steel bent. New 2015. Skewed.	New in 2015 but grout pads performing poorly. Cracking and spalling noted in previous reports. Cosmetic repairs using grout attempted since 2018 inspection.
5	07/16/21	18	Concrete Pier No. 1 of Section 2. Skewed. This part of bridge is original.	Failed bearing block under left stringer, common to sections I and 2, described in detail in Section 2. The shims under the intermediate bearings were noted loose during the 2018 inspection. They were repositioned and tighted in 2019 but are unsecured and working loose, just as they had between 2015 construction and 2019.

Bent 3 Looking South.

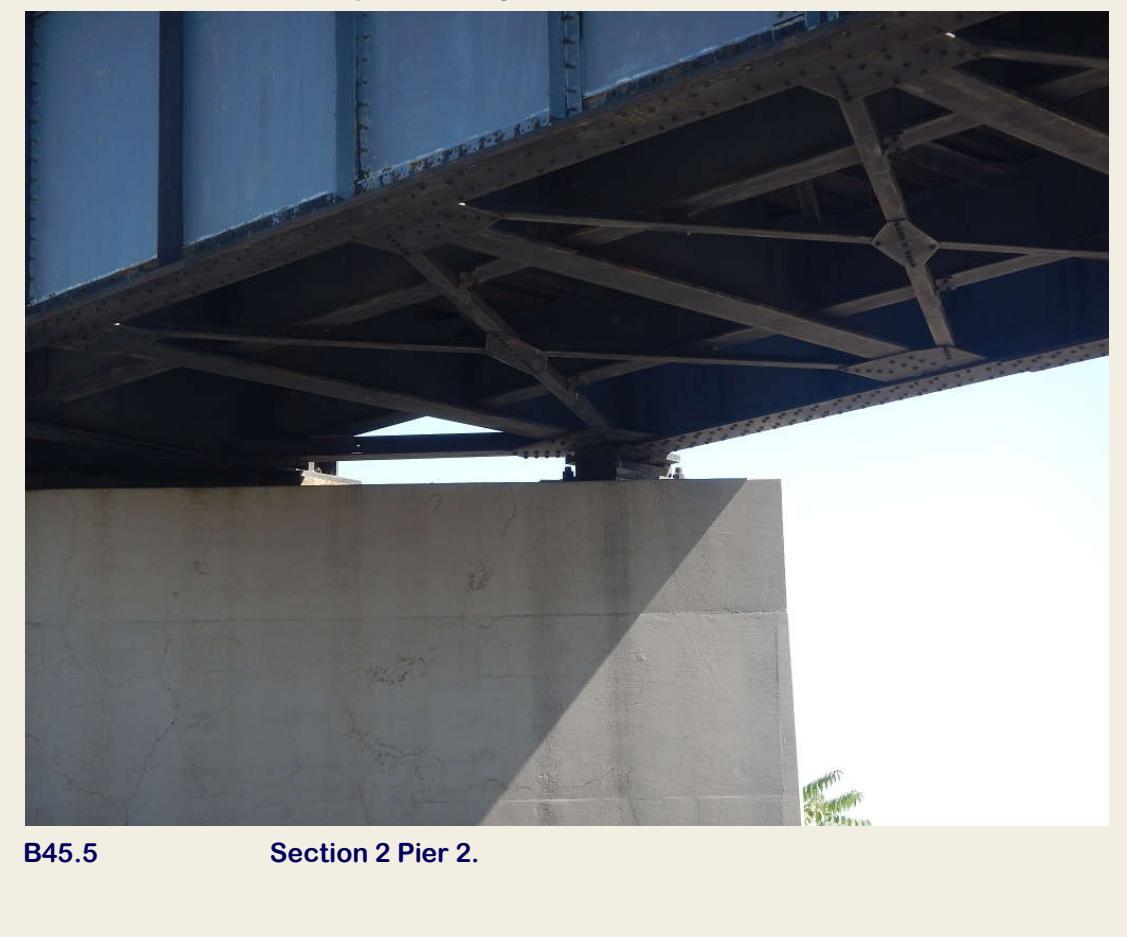
B45.5

Ties	New in 2	2015.]	Gener	al Warm	n and clear ski	es.				
V	/alkway	N/A] I	nspectio	on						
Appr	oaches	N/A] C	Commen	ts						
He	adwalls	N/A]								
Wi	ngwalls	N/A			Brief	Summai	v Conci	rete bearing b	ock at southwest	corner is bro	oken and no lon	ger cari	rying
I	Erosion	None			includi	ng Urger	nt load.	Shims under t	ies loose, risk fallii	ng onto highv	way.		
	Drift	N/A] (Conditic	on						
Veg	getation	None			SI	low Orde	r?						
PIERS	6 (inc Date	luding • Hg		TS) Description					Pier N	lotes			
I	08/27/2	20	Concrete			Conc	rete bearir	ng block under	left (west) end o	f lateral beam	n common to bo	oth sect	ions I
						and 2 Section	is broken on 1 stringe	and no longe er is picking up	r carrying load. It that load which	is likely that may lead to c	intermediate be cracking in steel.	aring fo	r
2	08/27/2	20	Concrete			\checkmark					-		
STEE			TE SPANS (
Span	Panel	Lngth	Date					Panel Note	s

I	9.4	08/27/20	2 rolled steel beams. So	me hook bo	olts and tie	spacer bolt	ts are loose. S	hims under ties a	re made of va	arious materials	and mai	ny are
				loose, some missing.

Main Span Looking North.

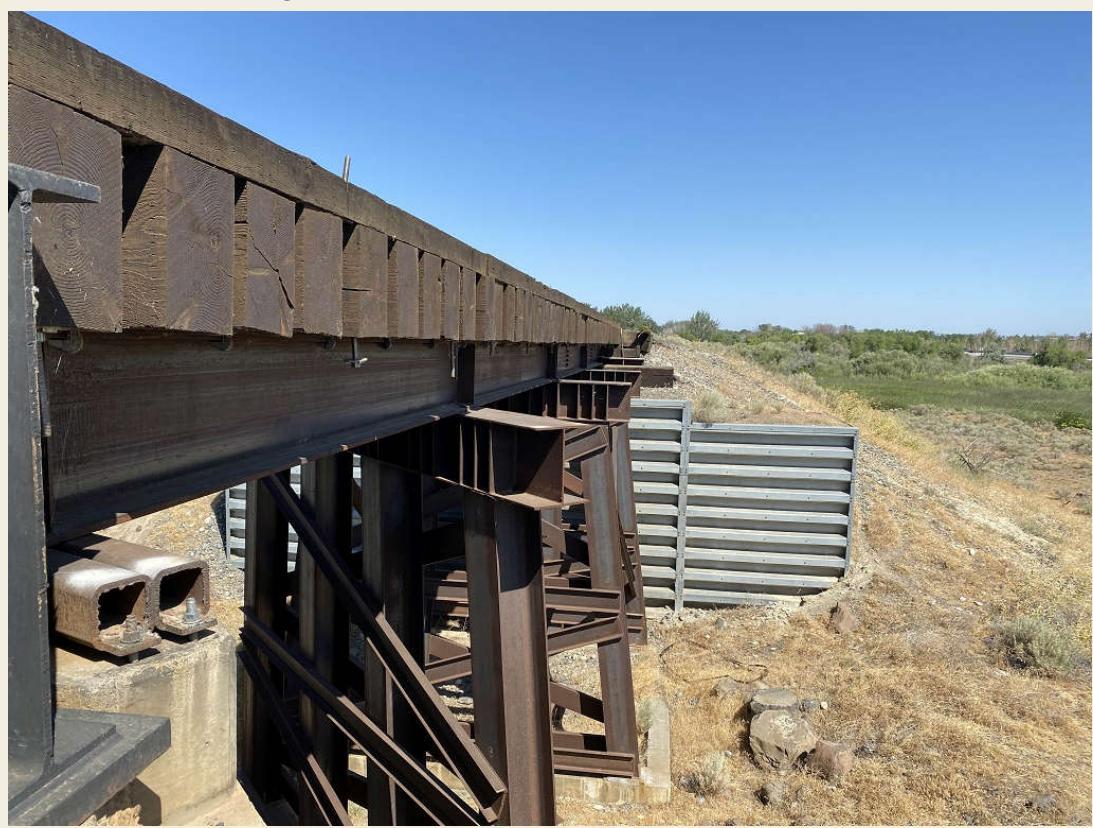
B45.5

Span	Panel	Lngth	Date	Panel Notes
I	0	15	07/16/21	4 rolled steel beams. Some hook bolts and tie spacer bolts are loose. Some tie spacer bolts are too short but functioning.
2	0	15	07/16/21	4 rolled steel beams. Some hook bolts and tie spacer bolts are loose. Some tie spacer bolts are too short but functioning.
3	0	15	07/16/21	4 rolled steel beams. Some hook bolts and tie spacer bolts are loose. Some tie spacer bolts are too short but functioning.

Right Side of Section 3

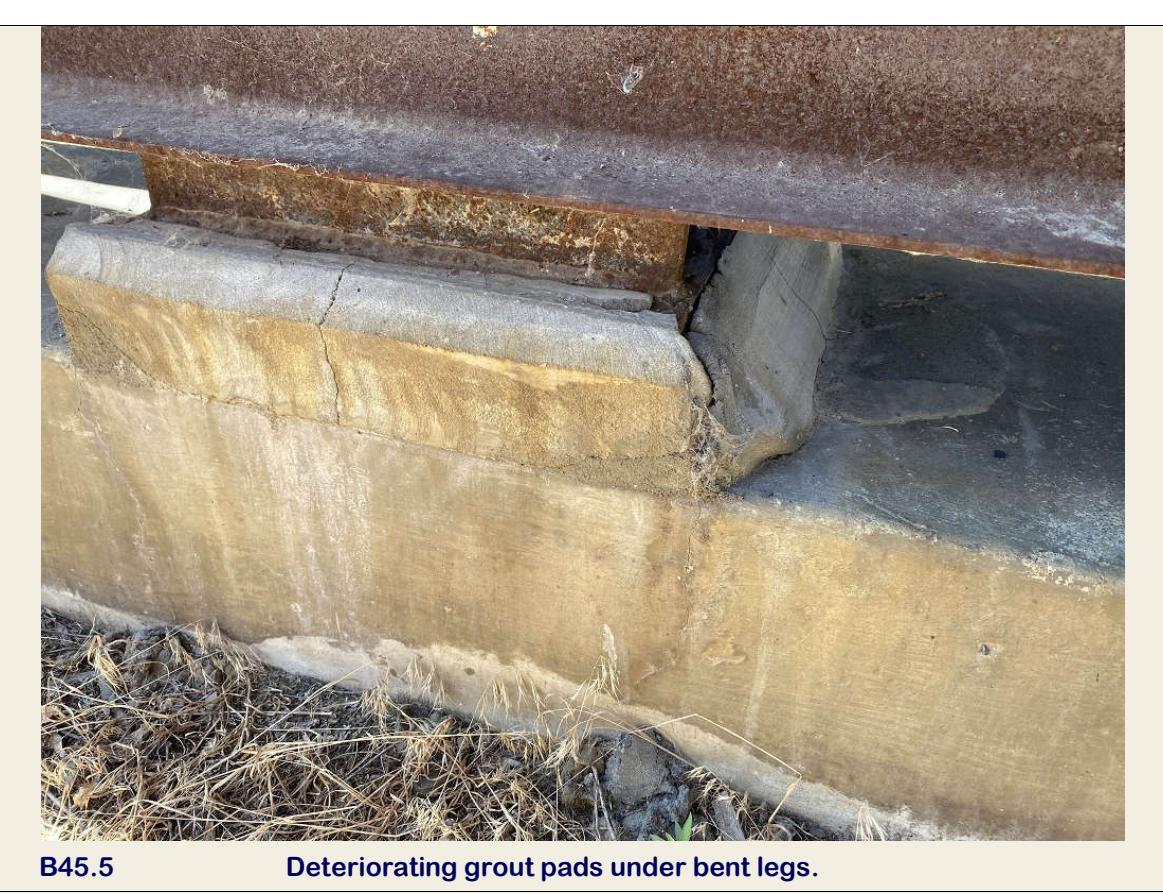
B45.5

Pier	Date	Hgt	Description	Pier Notes
Ι	07/16/21	18	Concrete Pier No. 2 of Section 2. Skewed. Original part of bridge.	The shims under the intermediate bearings were noted loose during the 2018 inspection. Those shims have since been repositioned and tighted but they are unsecured so will likely work loose in future, just as they have since 2015 construction.
2	07/16/21	18	4-column steel bent. New 2015. Skewed.	New in 2015 but grout pads performing poorly. Cracking and spalling noted in previous reports. Cosmetic repairs using grout attempted since 2018 inspection.
3	07/16/21	18	4-column steel bent. New 2015.	New in 2015 but grout pads performing poorly. Cracking and spalling noted in previous reports. Cosmetic repairs using grout attempted since 2018 inspection.
4	07/16/21	18	4-column steel bent. New 2015.	New in 2015 but grout pads performing poorly. Cracking and spalling noted in previous reports. Cosmetic repairs using grout attempted since 2018 inspection.

Looking North from Pier 2.

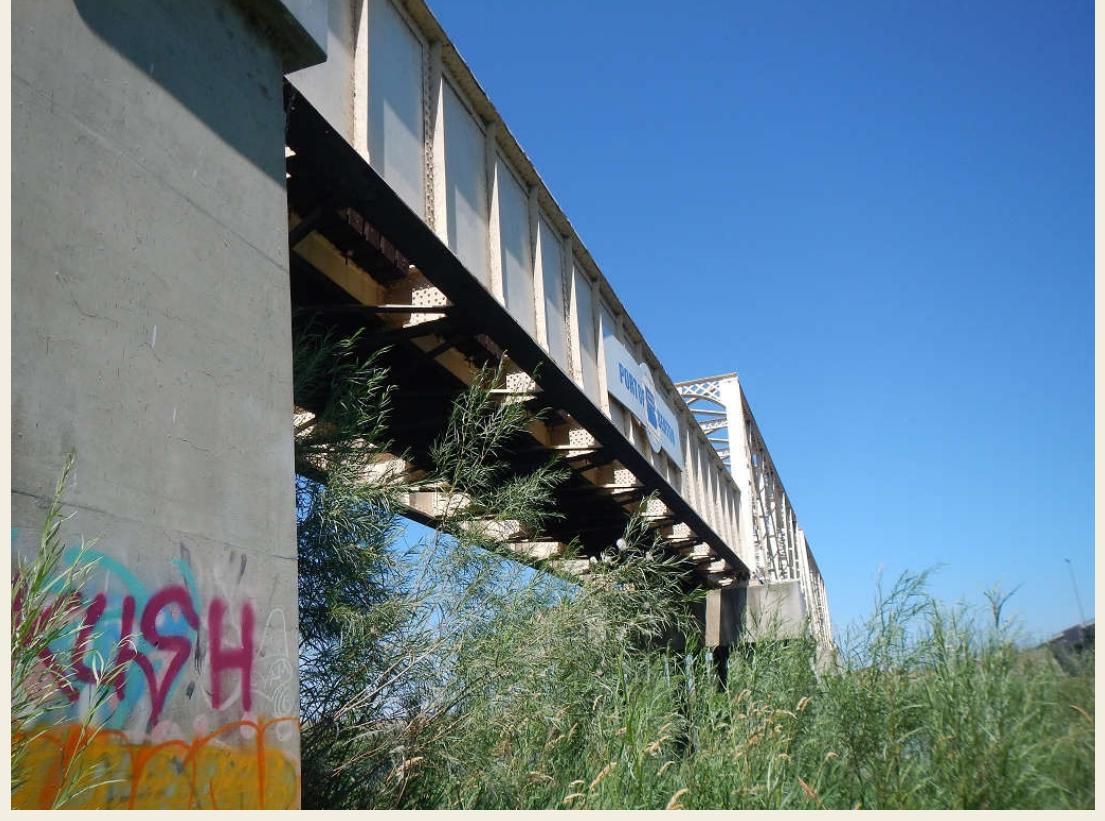
B44.4

Right Side Bearings of Section 2.

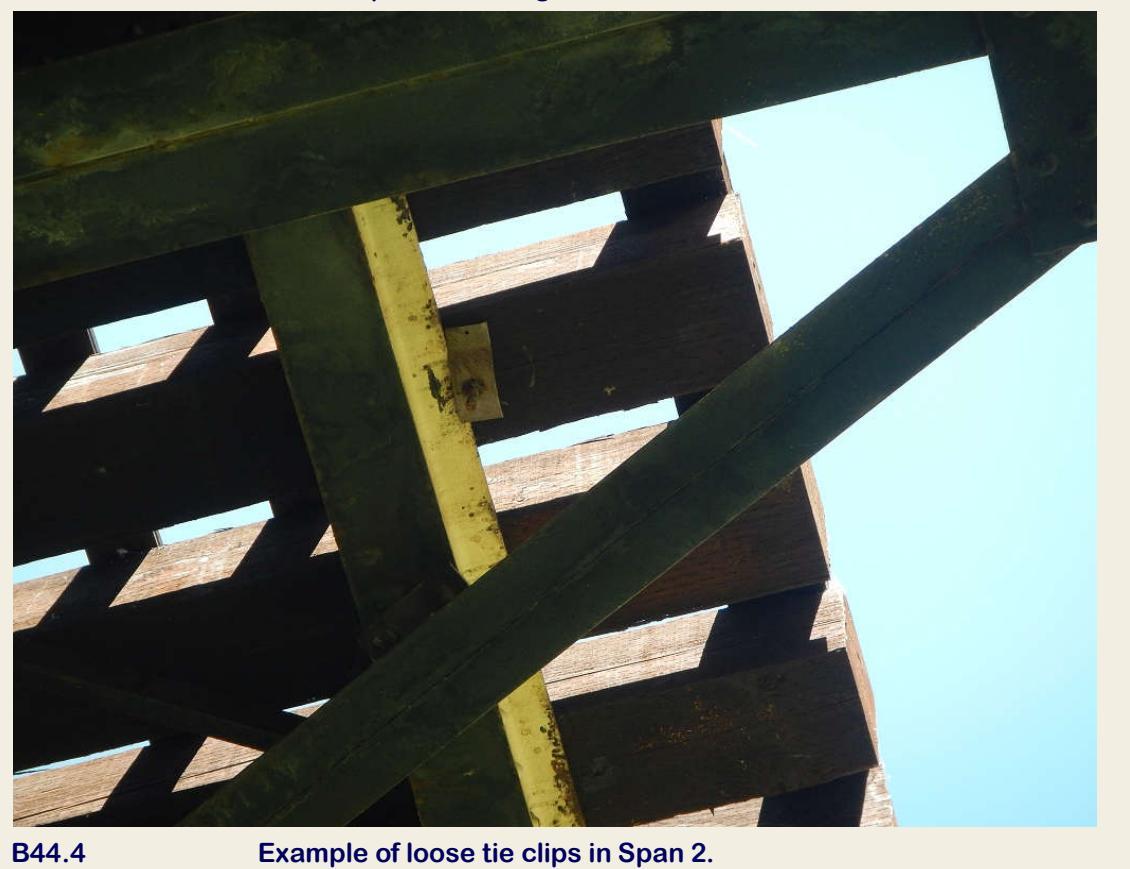
B44.4

with sections 3								
STEE	L/CO	NCRE	TE SPANS	by PANEL	.)						
Span	Panel	Lngth	Date	.			Pa	anel Notes			
1	-	9.75	07/16/21	throughout.							
	2	9.75	07/16/21	throughout.							
	3	9.75	07/16/21		throughout and pac	pack rust between top cover plates.					
	4	9.75	07/16/21	Bent Dottom late	rai brace. Minor co	corrosion throughout and pack rust between top cover plates.					
1	5	9.75	07/16/21	Minor corrosion	throughout and pac	K rust be	tween top co	ver plates.			
I	6	7./5	07/16/21	THINOP COPPOSION	unougnout and pac	.k rust De	ween top co	ver plates.

Side of Span 2 Looking Northwest.

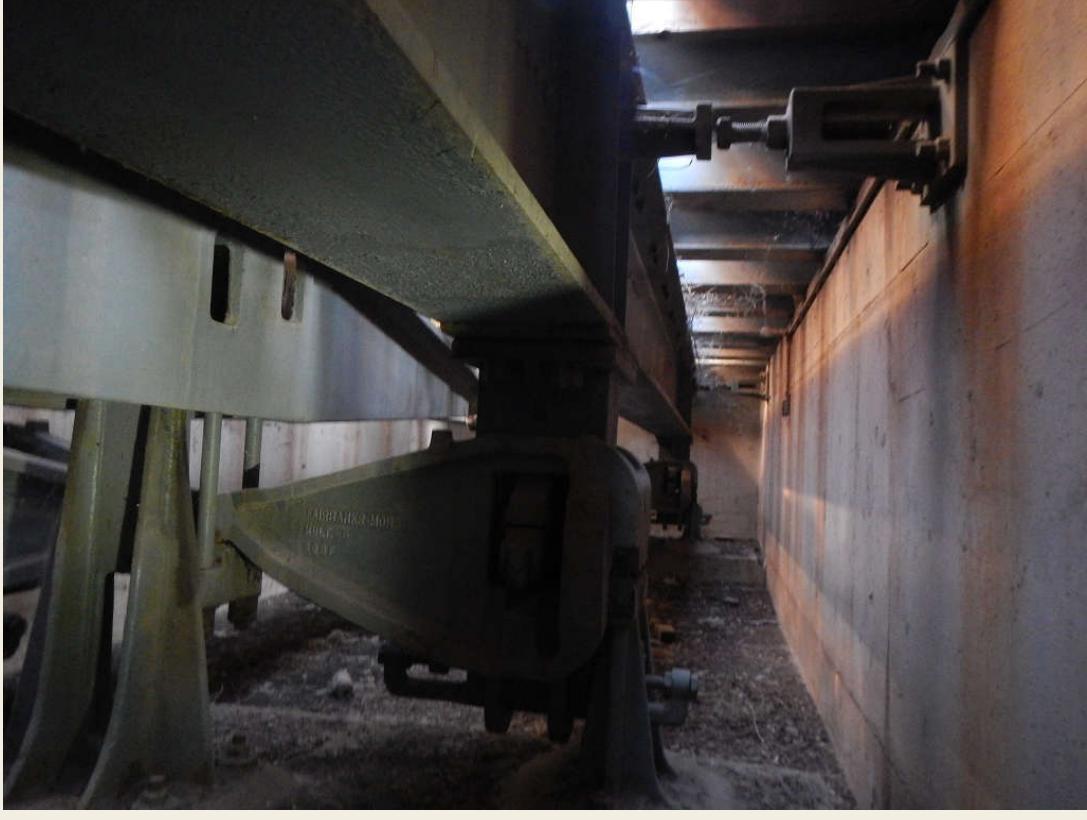
B37.7

Scale Pit Center.
