Existing Conditions Study Report

RICHLAND, WA

JULY 20<sup>TH</sup>, 2023

# STRUCTURAL EVALUATION REPORT

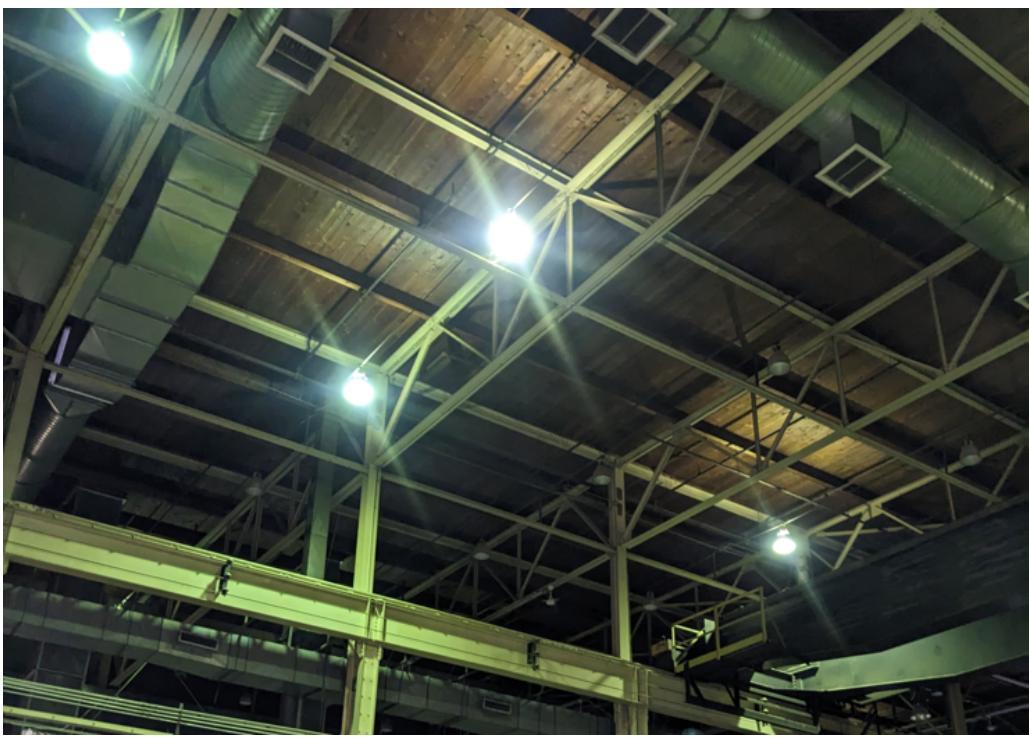
Figure 3: Typical Underside of Roof

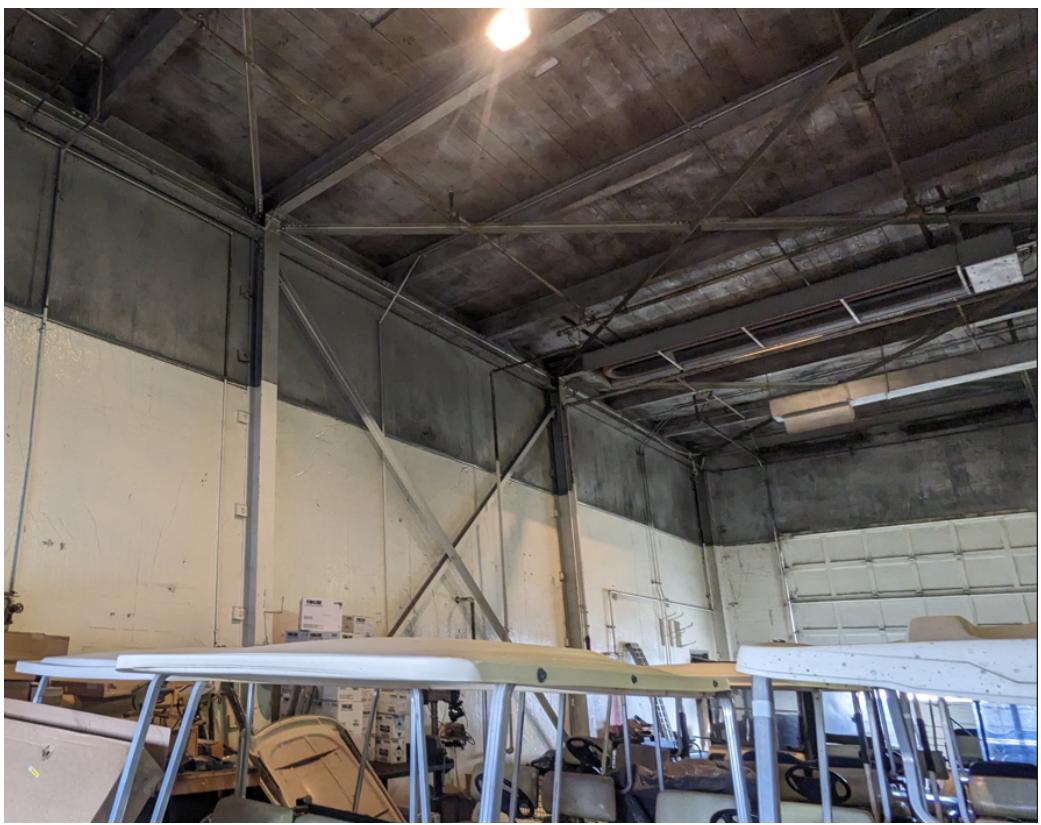
Figure 4: Braced Frame at Exterior Concrete Wall

- The exterior concrete walls and non-bearing interior masonry walls likely participate in the building response to gravity and lateral loadings, which may have a detrimental effect on building performance in a high snow event or seismic event, respectively.
- Several deficiencies at braced frame locations including insufficient anchorage of braced frame columns to the foundation, noncompact braced frame members

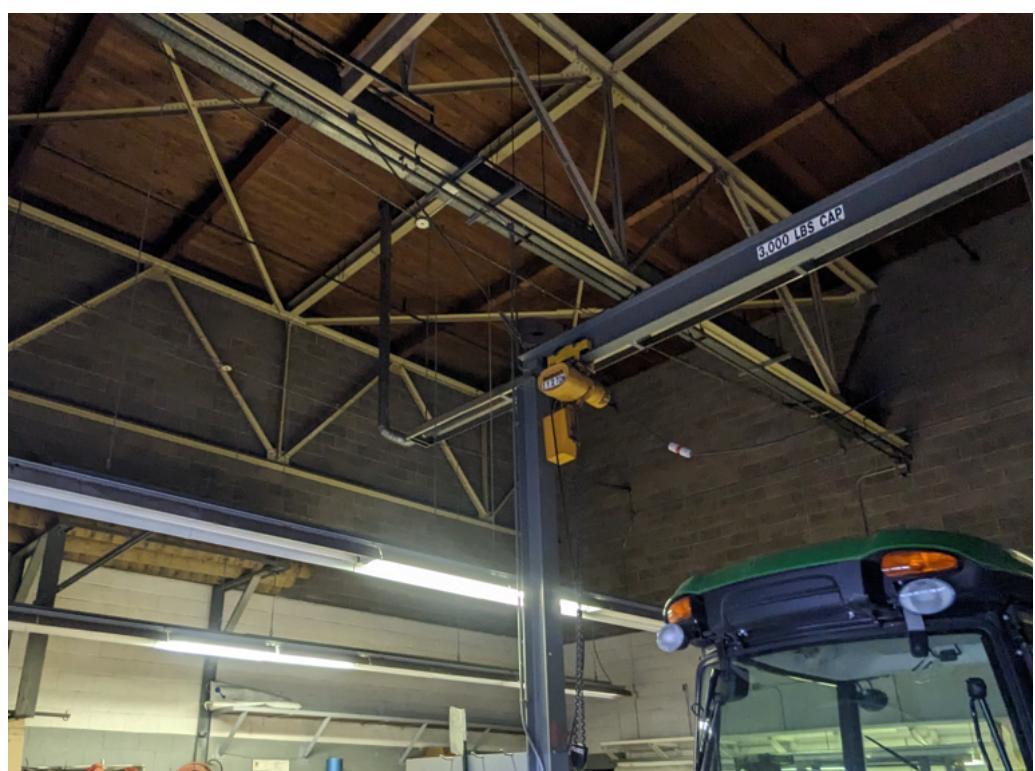
Figure 6: Masonry Wall Installed Tight to Structural Roof Framing

- 3) KPFF recommends further evaluation of non-bearing masonry wall to primary roof structure interfaces and recommend modification to these systems where found to be detrimental to life safety of building occupants.

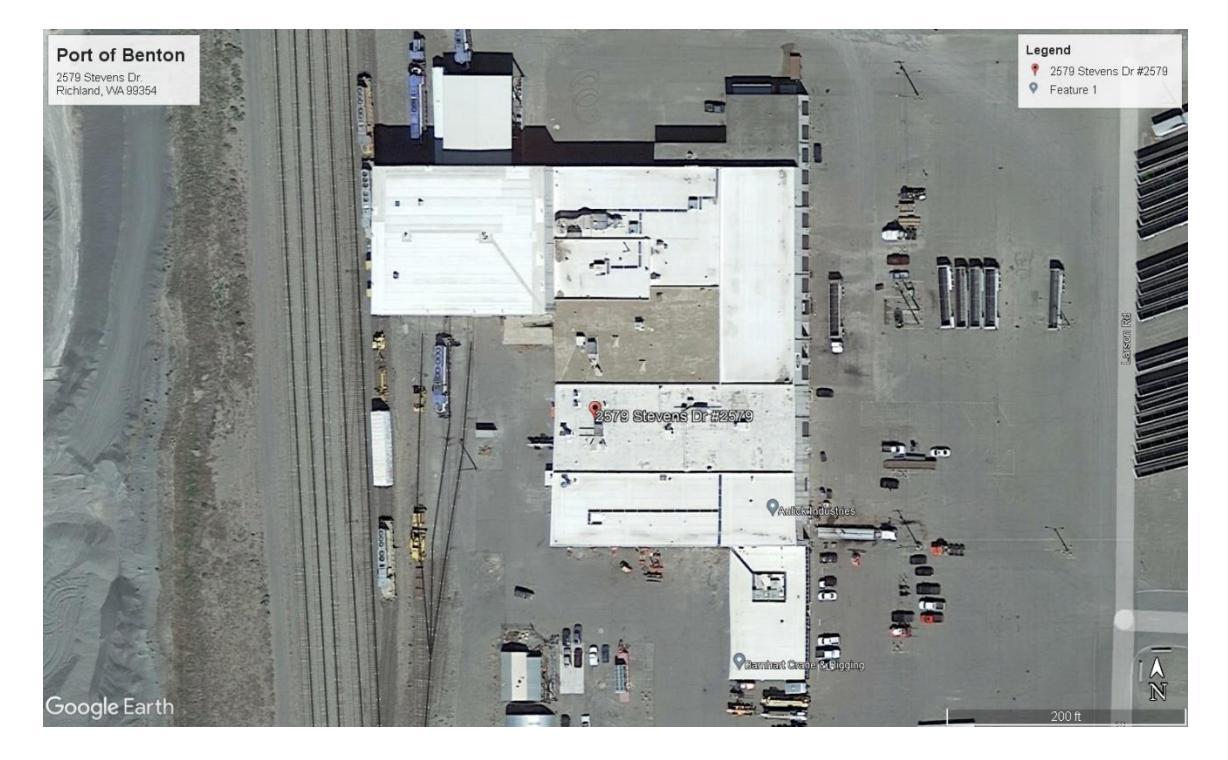
<b>DEFICIENCIES NOTED:</b>		Failed Details at penetrations, caulking
	-	Thermal bridging of fasteners
	-	Checkering of membrane waterproofing
	-	Ponding water
	-	Failing seams of membrane
	-	Active Leaks and existing repair areas
	-	Active water infiltration throughout Single Ply
		and SPUF Roofs

- Wet Insulation (1,950 sq.ft.)

I have categorized Area 4, 6, & 7 as a replacement or overlays due to drainage, ponding issues, wet insulation and overall conditions. Areas 1, 8 & 9 fall into a restoration category due to the membrane wear, wet insulation and deficient waterproofing details. Areas 2-3 & 5 are all in fair to good condition and can be scoped for a maintain category which can provide new waterproofing details to be applied in specific areas to ensure the roof stays watertight and in good condition.

All areas of wet insulation must be removed and replaced in a like-kind profile before restoration can take place. All replacement and restoration scopes are listed below and asbestos testing must take place before the removal of any job site materials. The following process includes; all specifications and drawings, on-site management, pre-bid, pre-construction and progress meetings, final inspection, project closeout book with QA Warranty and built-in inspection.
