# **Southern Connection – POB Industrial Rail Spur Rail Maintenance Cost Study C2024-12**

**Jeffrey Guelker  
JCG Consulting**

**5/3/2024**

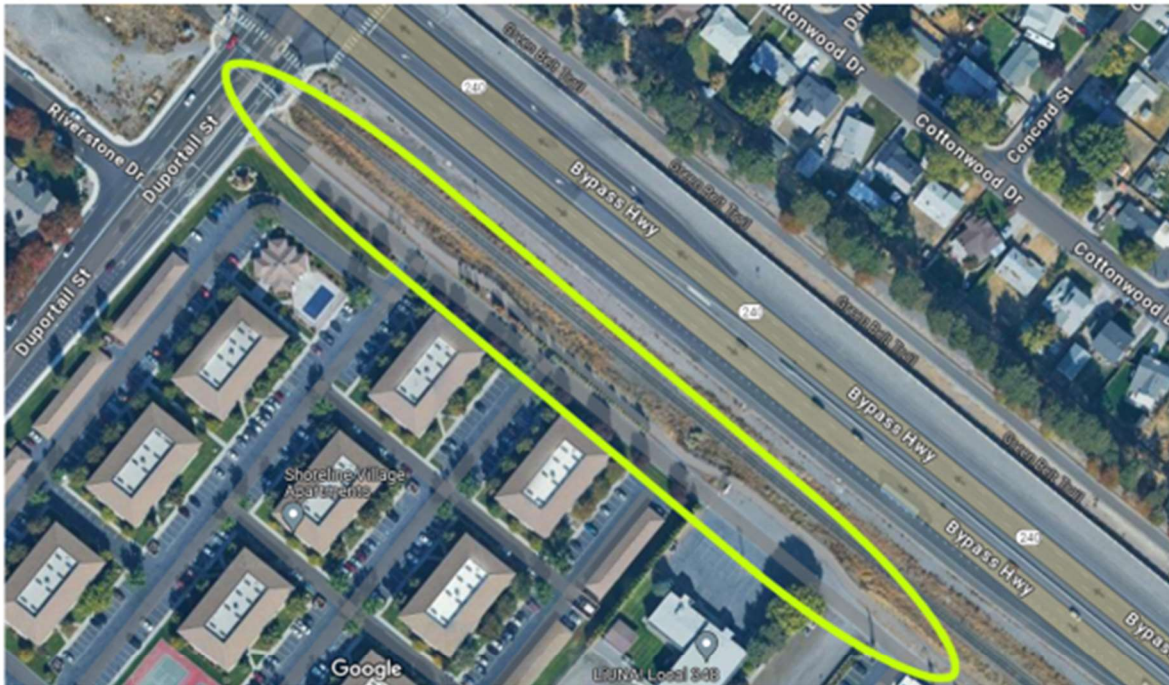
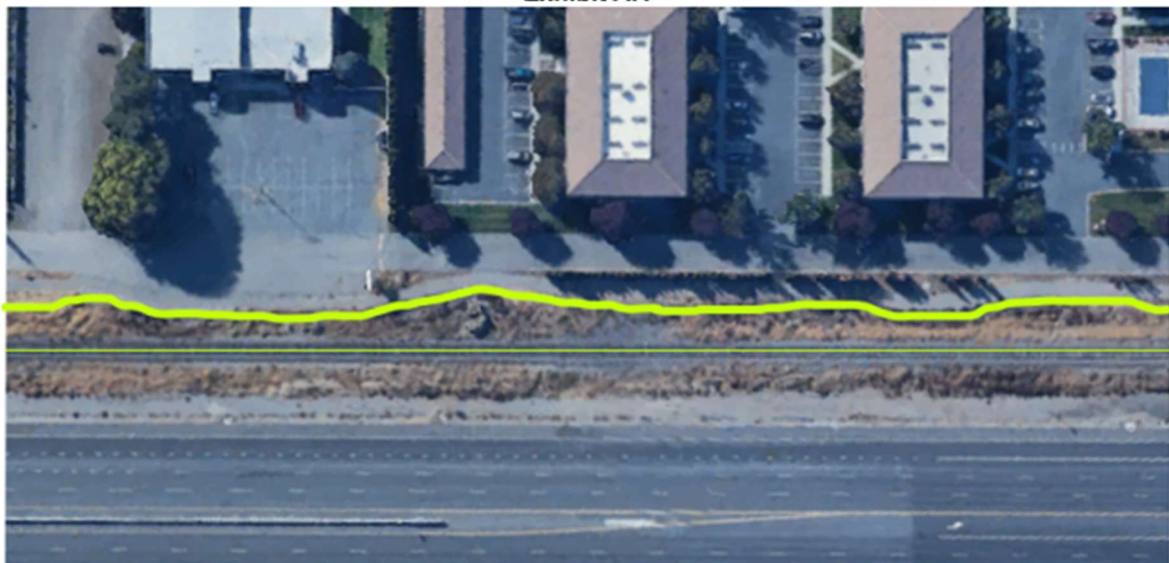
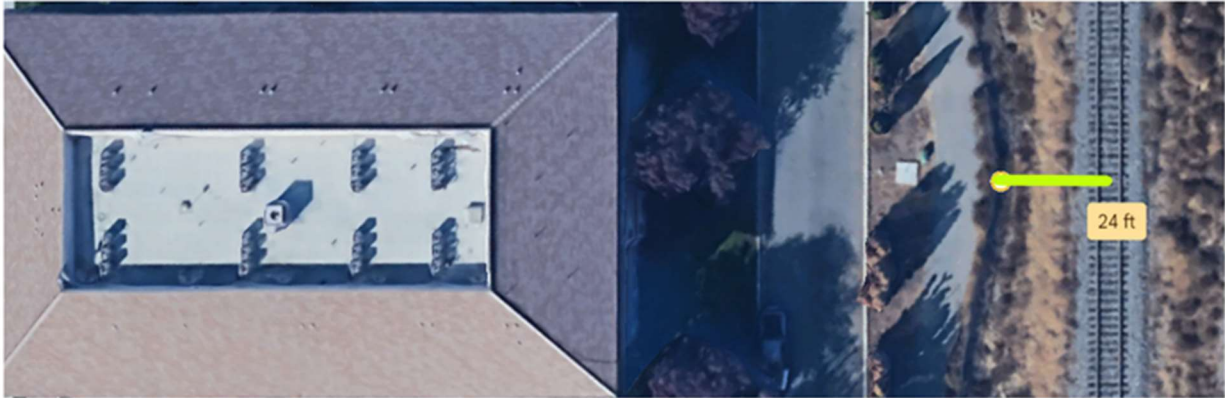
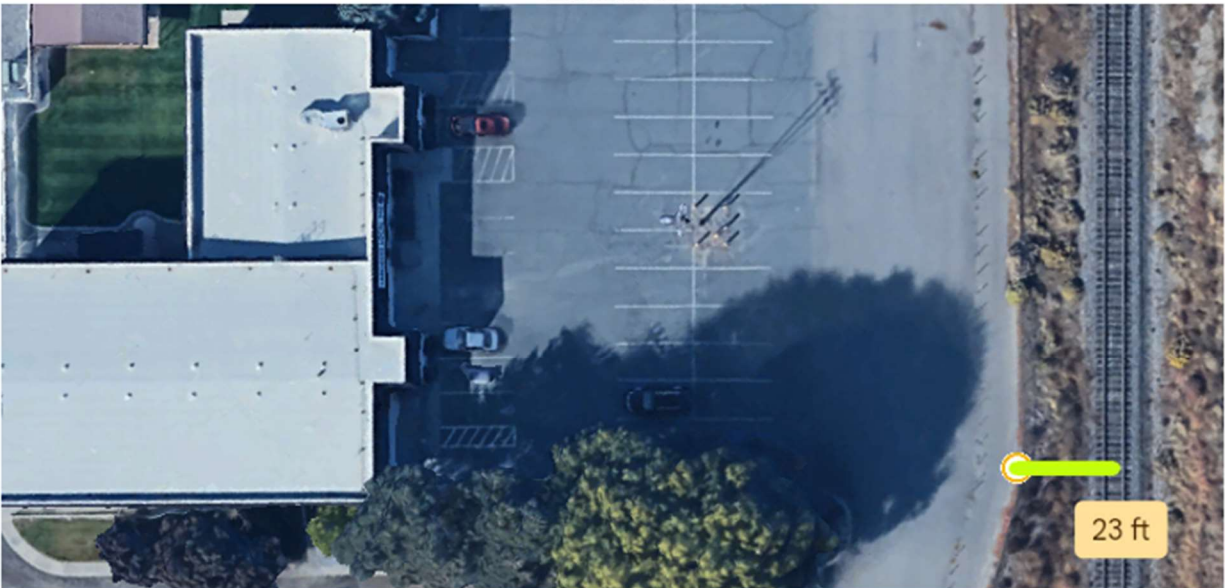
Within close proximity of the Shoreline Village Apartments and the adjacent business just south of the intersection of Bypass Hwy 240 and Duportail Street, a bike/walking path has been erected within 25 ft of the mainline track center (Exhibits A.1, A.2, A.3, A.4)

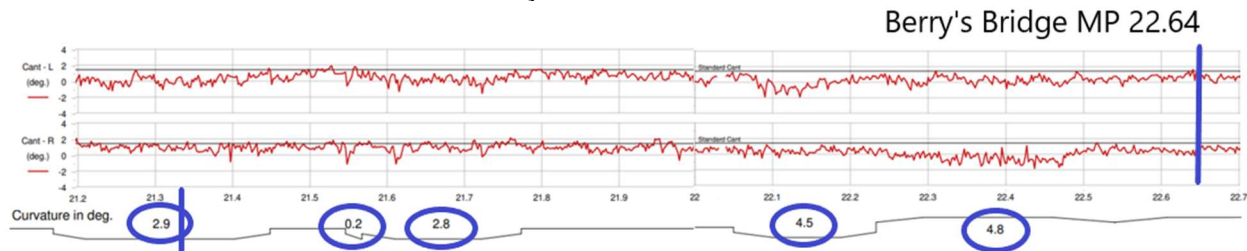
**Exhibit A.6**

Reviewing the geometry car chart in Exhibit A.6, the rail's cant

- measure of tilt or roll in the rail
  - that keeps the point of wheel contact centered on the rail head
  - shows some erratic variability.

CANT exceptions have been identified as probable causes of rail rollover and gauge widening derailment per the following studies:

While most of the rail in this span of track is 115lb, ongoing frequent inspections are recommended until said time that

- defective tie replacements can occur
- and the rail weight can be upgraded to 136lbs.

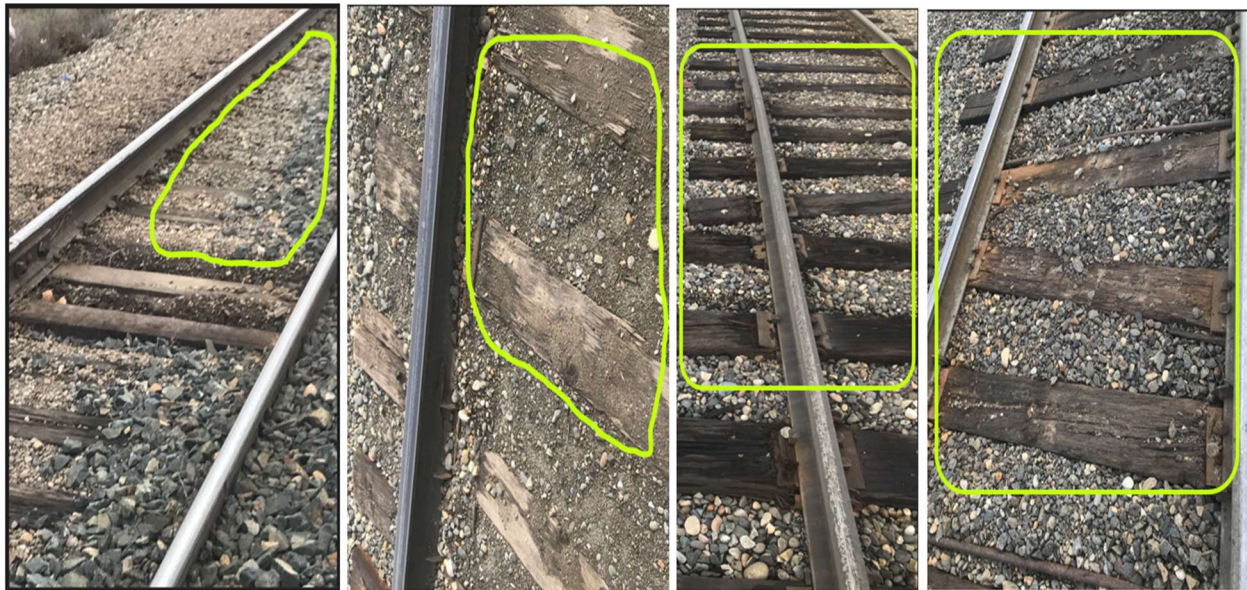
**Exhibit A.13**

Exhibit A.13 provides a ground view perspective of the aerial photo callouts of Exhibit A.10, A.11, and A.12. Starting left to right, it is clear that railroad ties are buried underneath ballast, dirt, and mud. The shifting of ties into a zig zag "Z" position are easily discernible in the two rightmost pictures of Exhibit A.13.

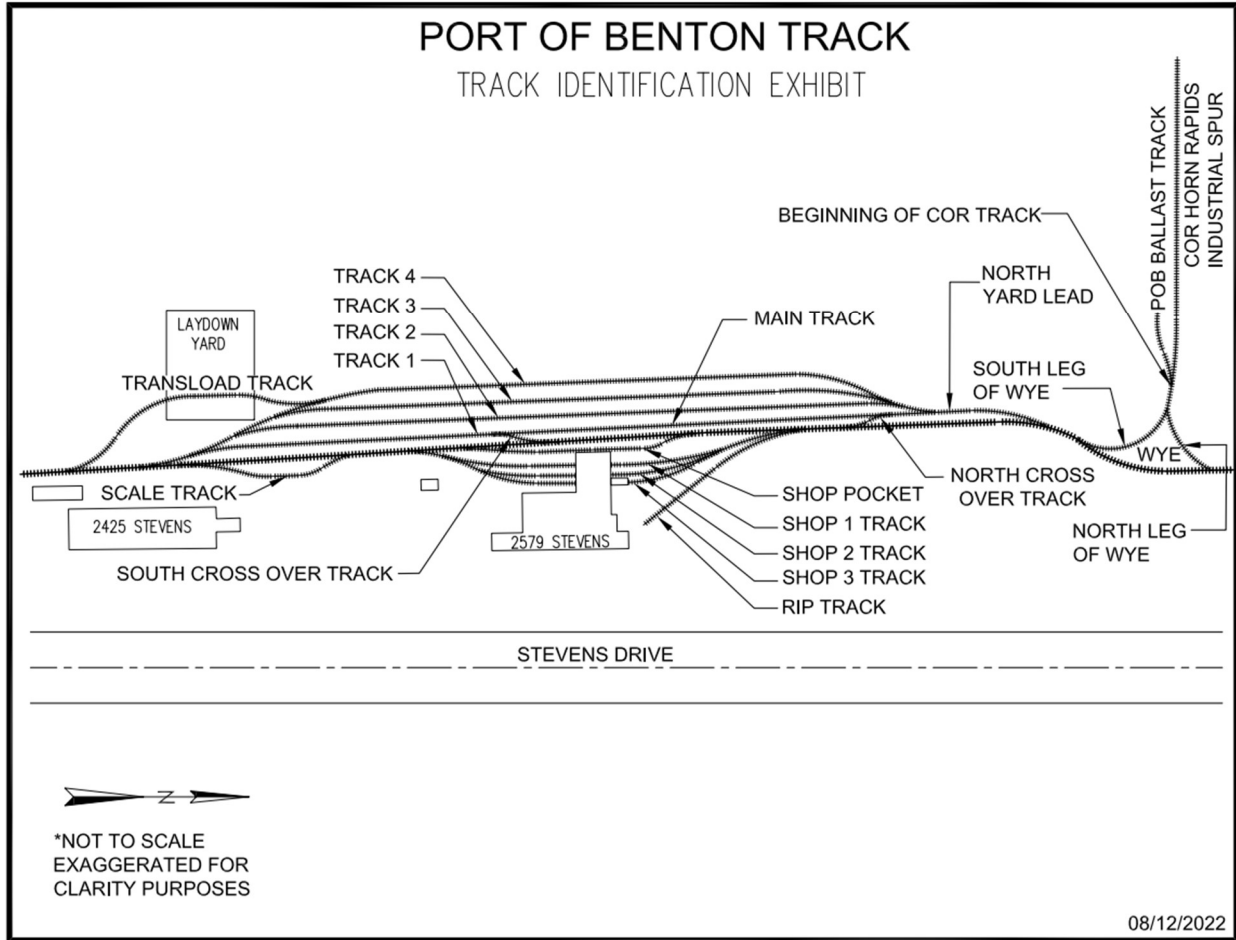
**Exhibit A.25**

The POB railyard located at 2579 Stevens is currently only being used for random car storage by Columbia Rail for CWCP cotton seed cars, and some track infrastructure raw materials. The yard as depicted in Exhibit A.25 consists of:

- Four yard tracks running parallel to the main line
- A transload track (laydown yard) that is not being used
- A non-functioning scale track with some track infrastructure raw materials being stored.
- Four short shop tracks
- North yard lead
- And a short spur track (originally a Rip track) now being utilized by BioGro customer.

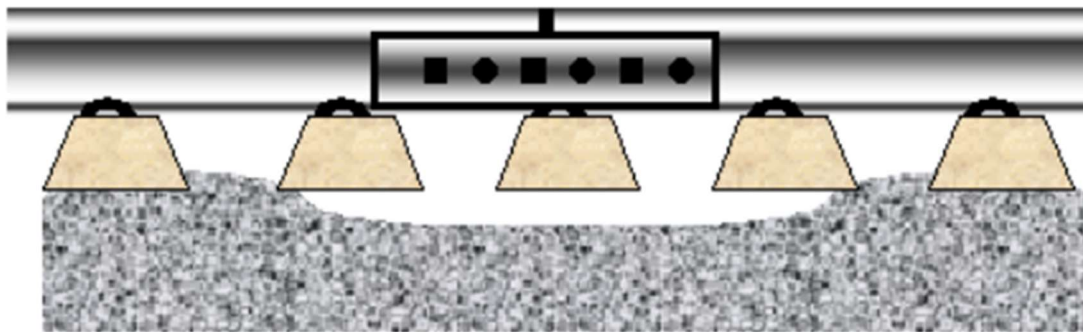
**Exhibit D.13**

“Defects in a rail joint may cause excessive pounding, as wheels pass over it. This continued series of impact loads causes a breakdown of ballast support under the joint ties. A low spot in the surface develops. Perhaps the joint begins to pump mud. It is not unusual for the track to develop a line irregularity at this spot. Depending on the position from which he/she is observing the track, the trained inspector might observe either the line or the surface defect first.”

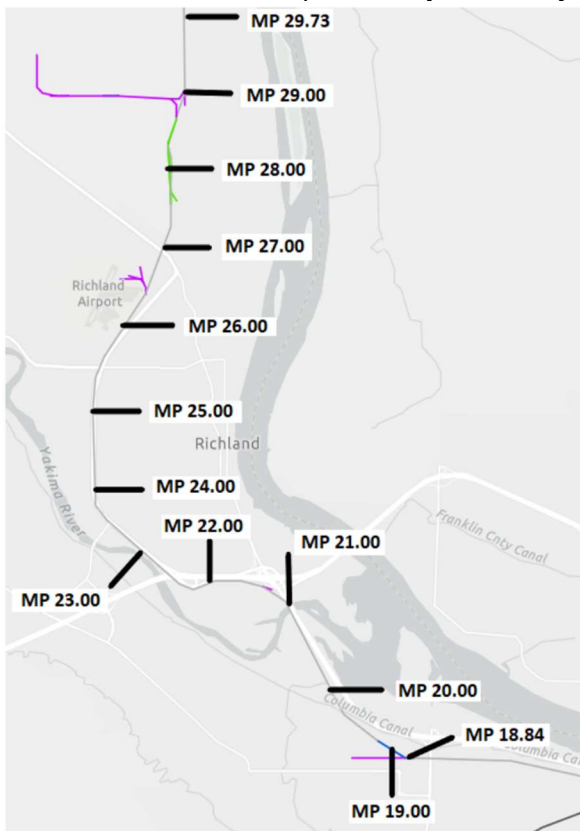
**Findings:** The collected data provides a comparison of overall tie condition between “formal inspections”. It is important to note that some tie remediation has been taking place during the 34 months between inspections.

- From Richland Jct. (MP 18.84) through MP 24.00, data shows that a positive reduction in the number of defective and marginal / fair ties has occurred.
- From MP 24.00 through MP 29.73, a positive reduction in the number of marginal / fair ties has occurred, but there has been a substantial increase in the number of defective ties.
  - Hypothesis:
    - Tie remediation work has helped to reduce the number of defective and marginal / fair ties.
    - A good percentage of the marginal / fair ties have further degraded into defective ties.
    - Two companies may be classifying ties slightly different.

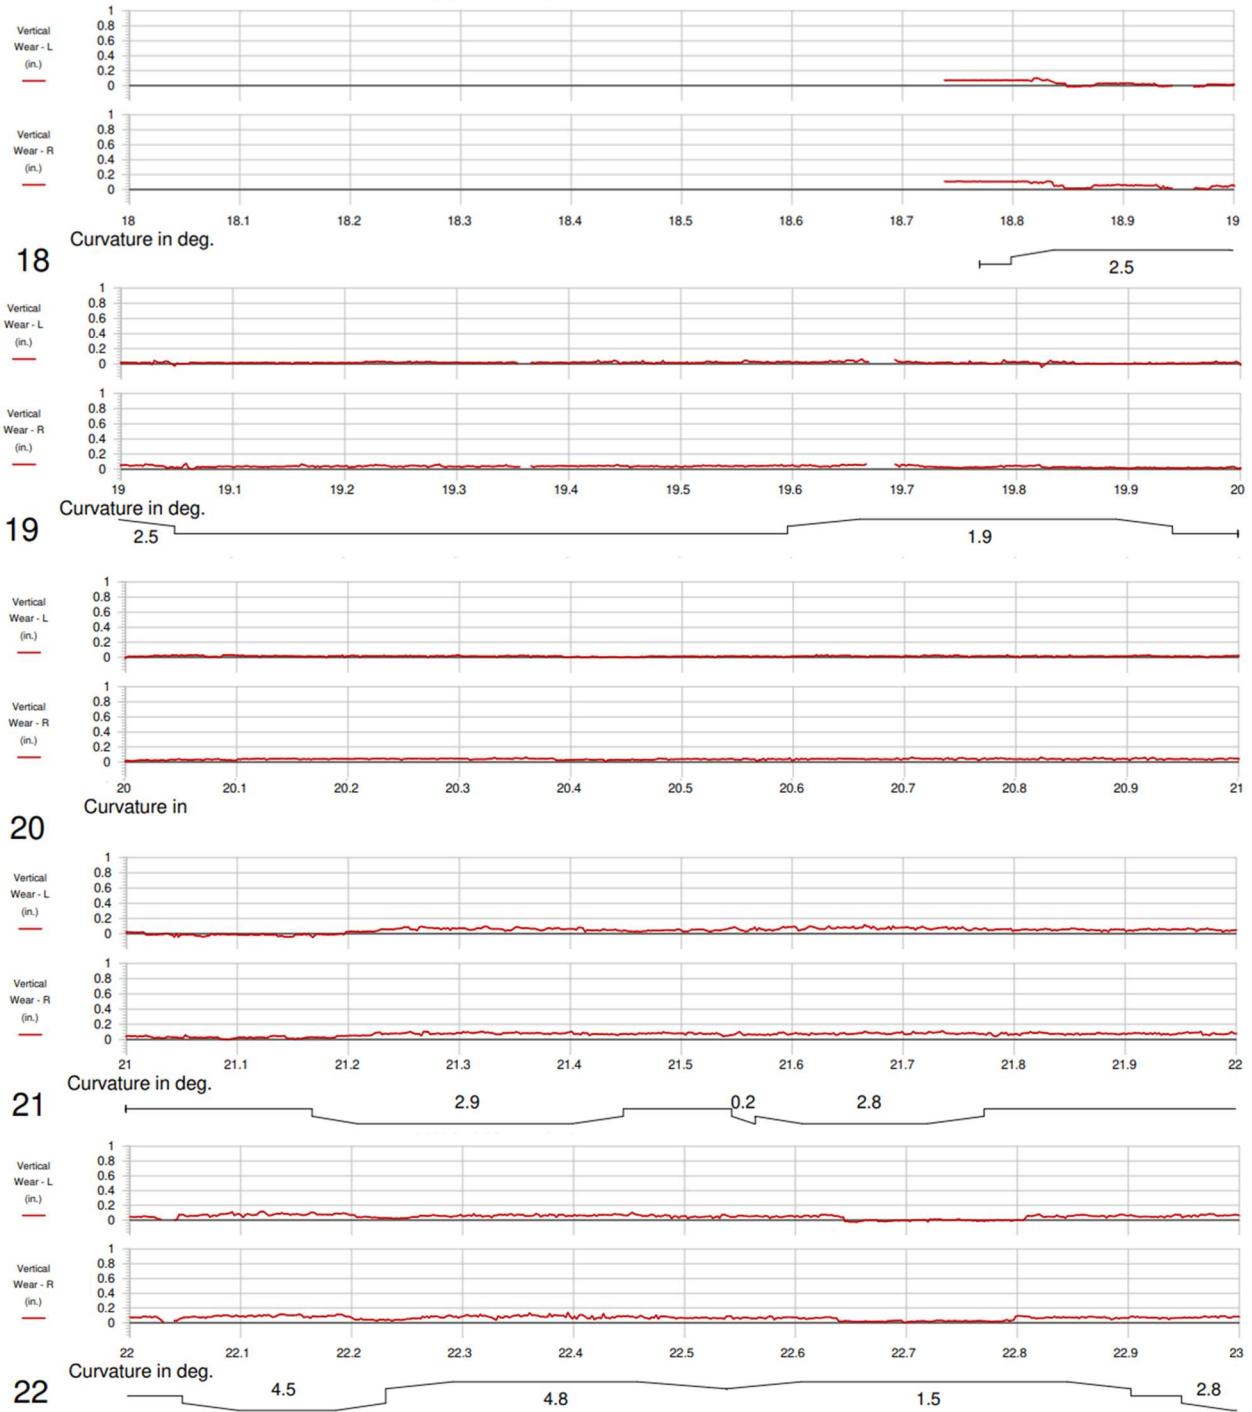
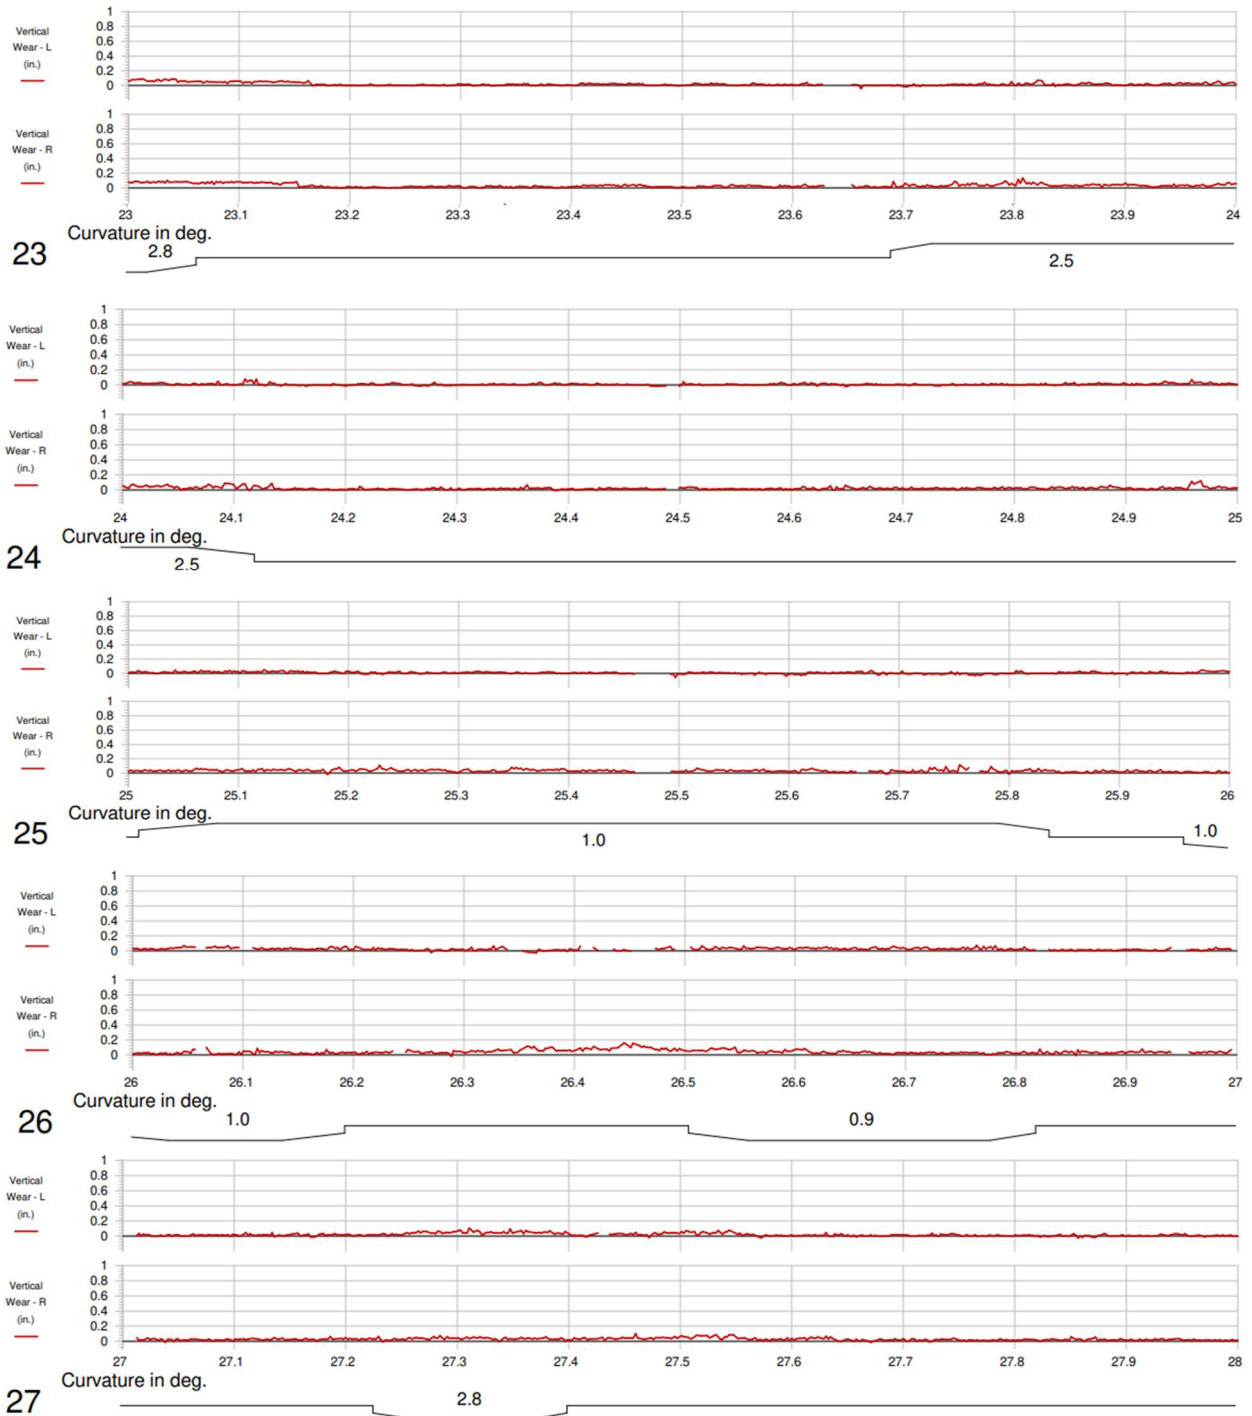
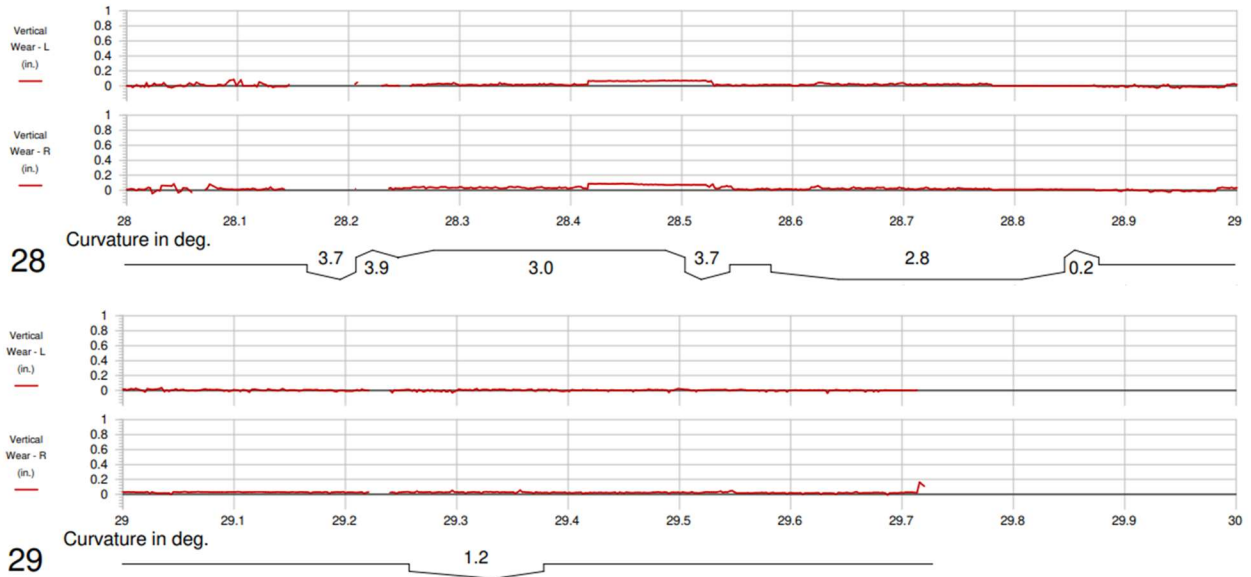
**Vertical Wear Findings:** The data from the October 11, 2023 Geometry Car inspection report looks very promising from a Vertical Wear perspective on the side of the steel rail head across the POB's mainline track. Recall the following definition for Vertical Wear:

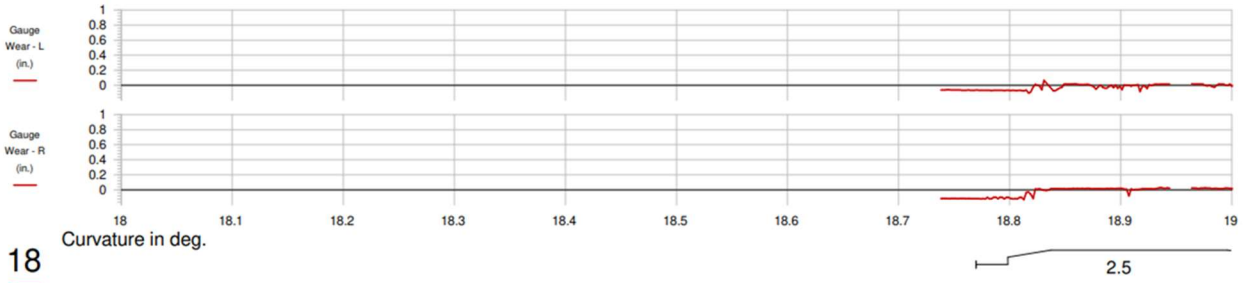
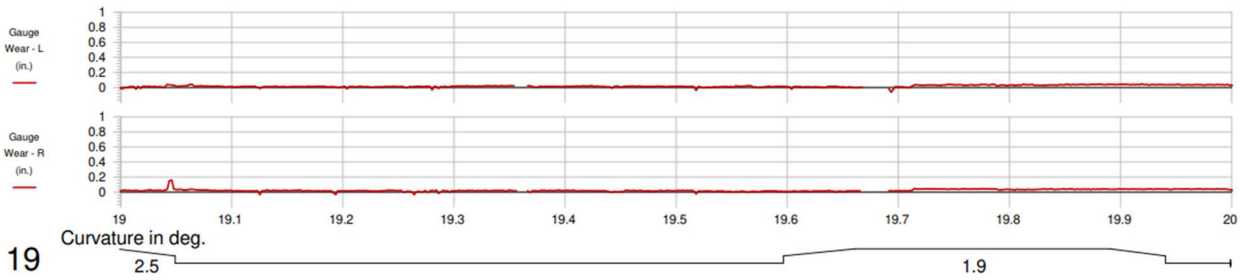
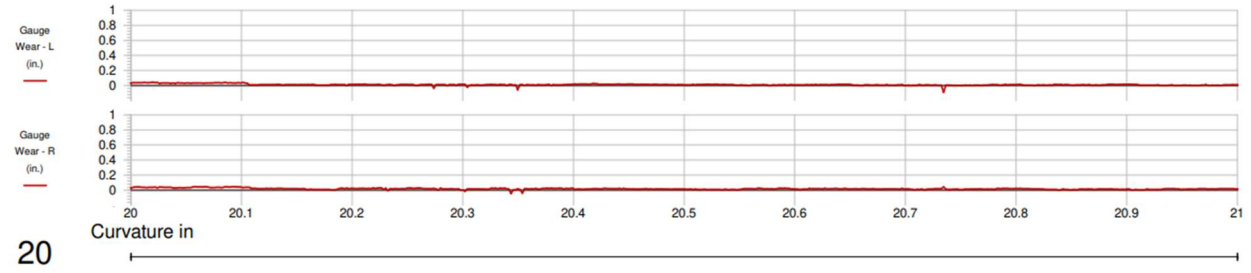
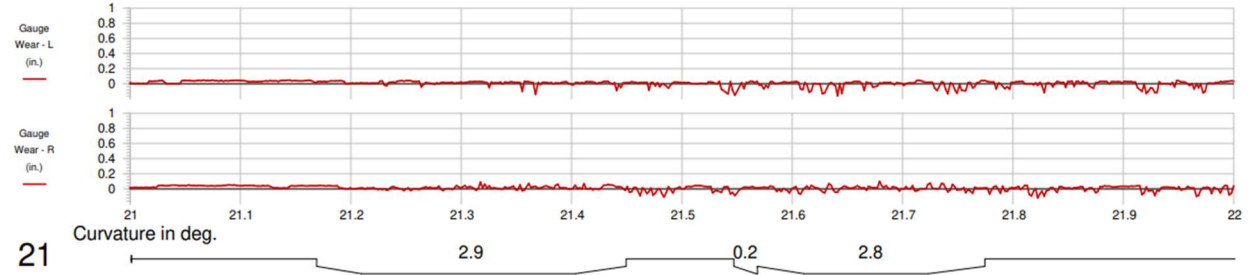
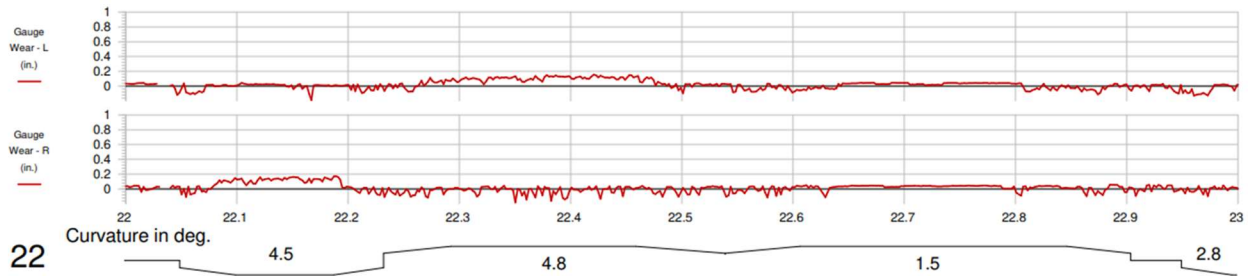
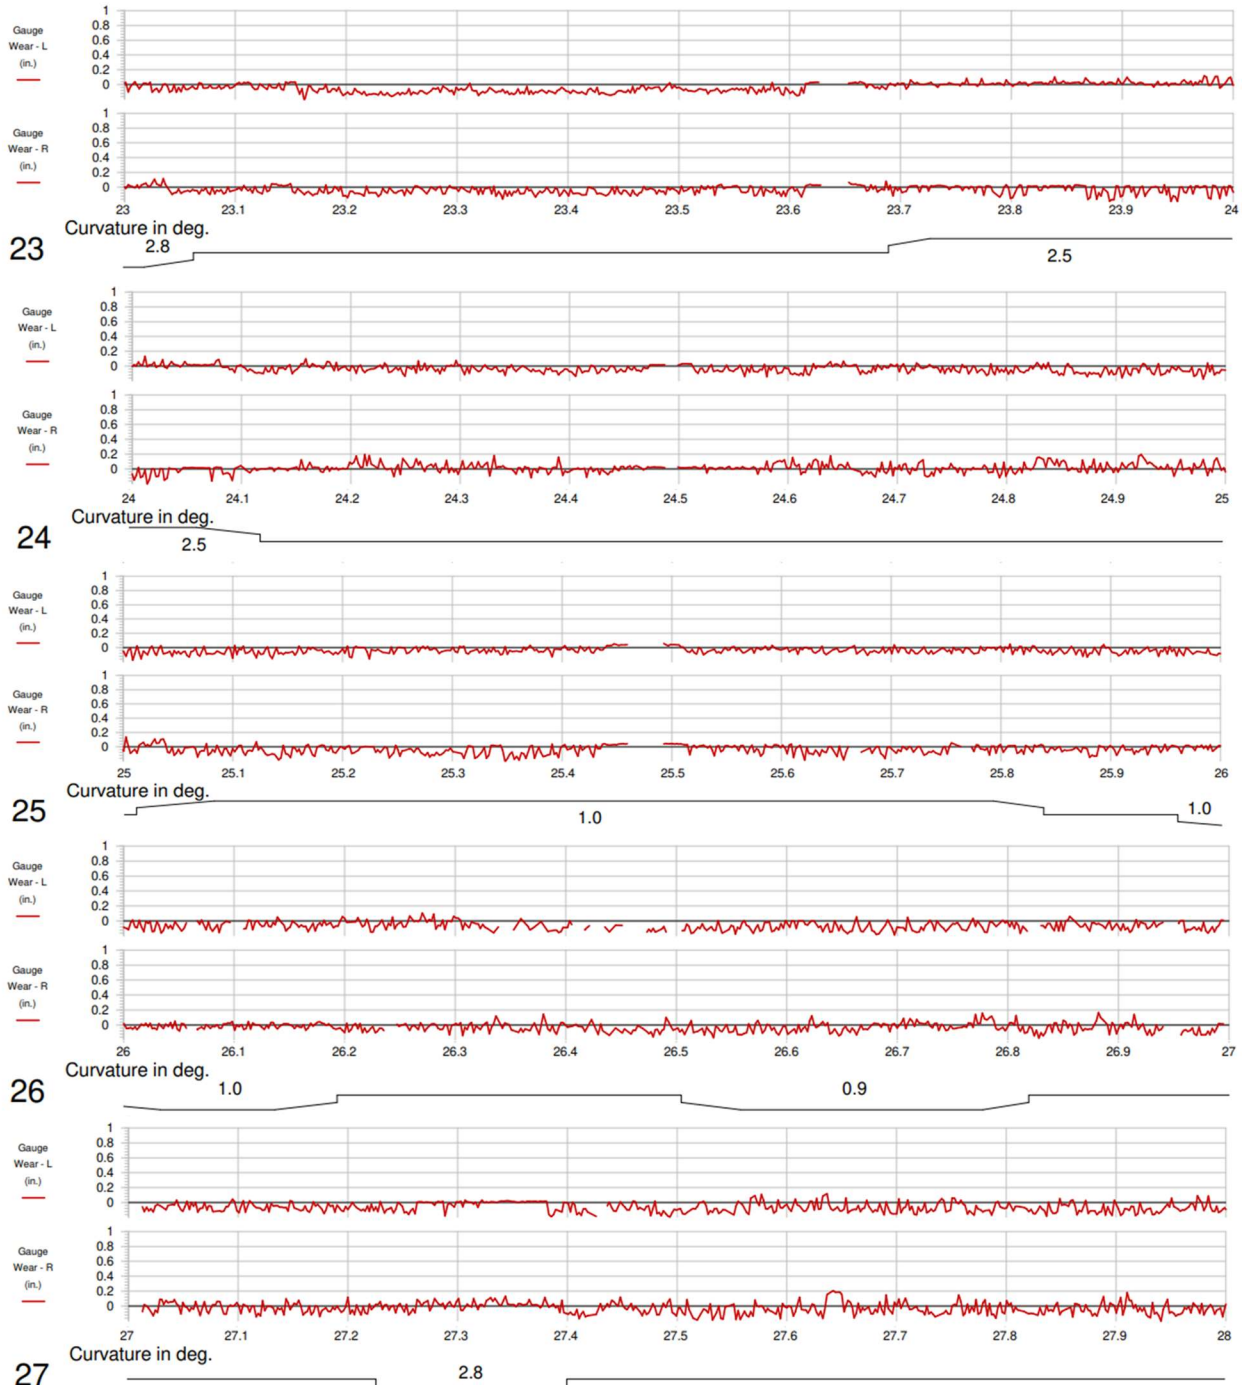
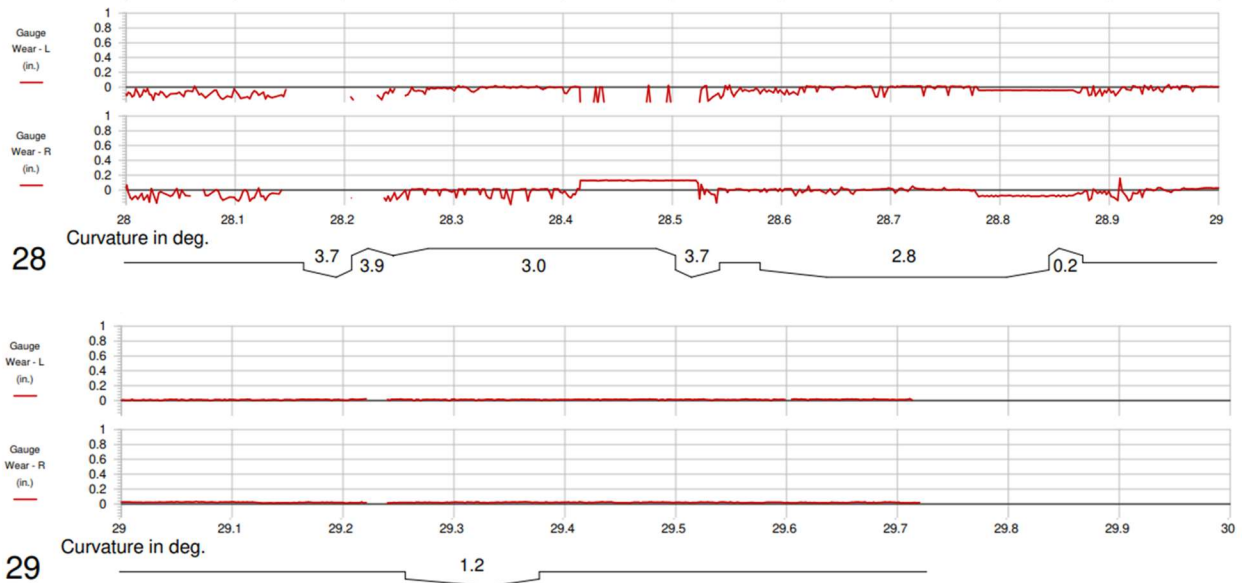
**Gauge Findings:** The data from the October 11, 2023 Geometry Car inspection report looks very promising for gauge from Richland Jct until City Dock (MP 21.51) where the beginnings of gauge distance starts to vary with each few feet of forward movement. Between Jadwin Ave. and Berry's Overpass we begin to see widening of the rail as we enter the big curves of the POB track. Gauge measures continue to be erratic but minimal until just north of Cemetery Road prior to Van Giesen, which was anecdotally identified by BNSF crew members, BNSF Trainmaster, UP Trainmaster, and Columbia Rail Operations Manager and Engineer as being some of the worst condition track to operate over. The main track thru the POB yard up until the south leg of the wye shows the most gauge variability of all. Gauge movement is the result of poor tie condition which prevents the spike from staying tightly inserted into the railroad tie thus not allowing for properly fastening of the rail down via the tie plate.

Supporting this statement, the highest number of consistently defective and marginal / fair ties reside between just north of Duportail Street at MP 23.67 through just shy of the POB railyard at MP 27.29. (Exhibit D.20)

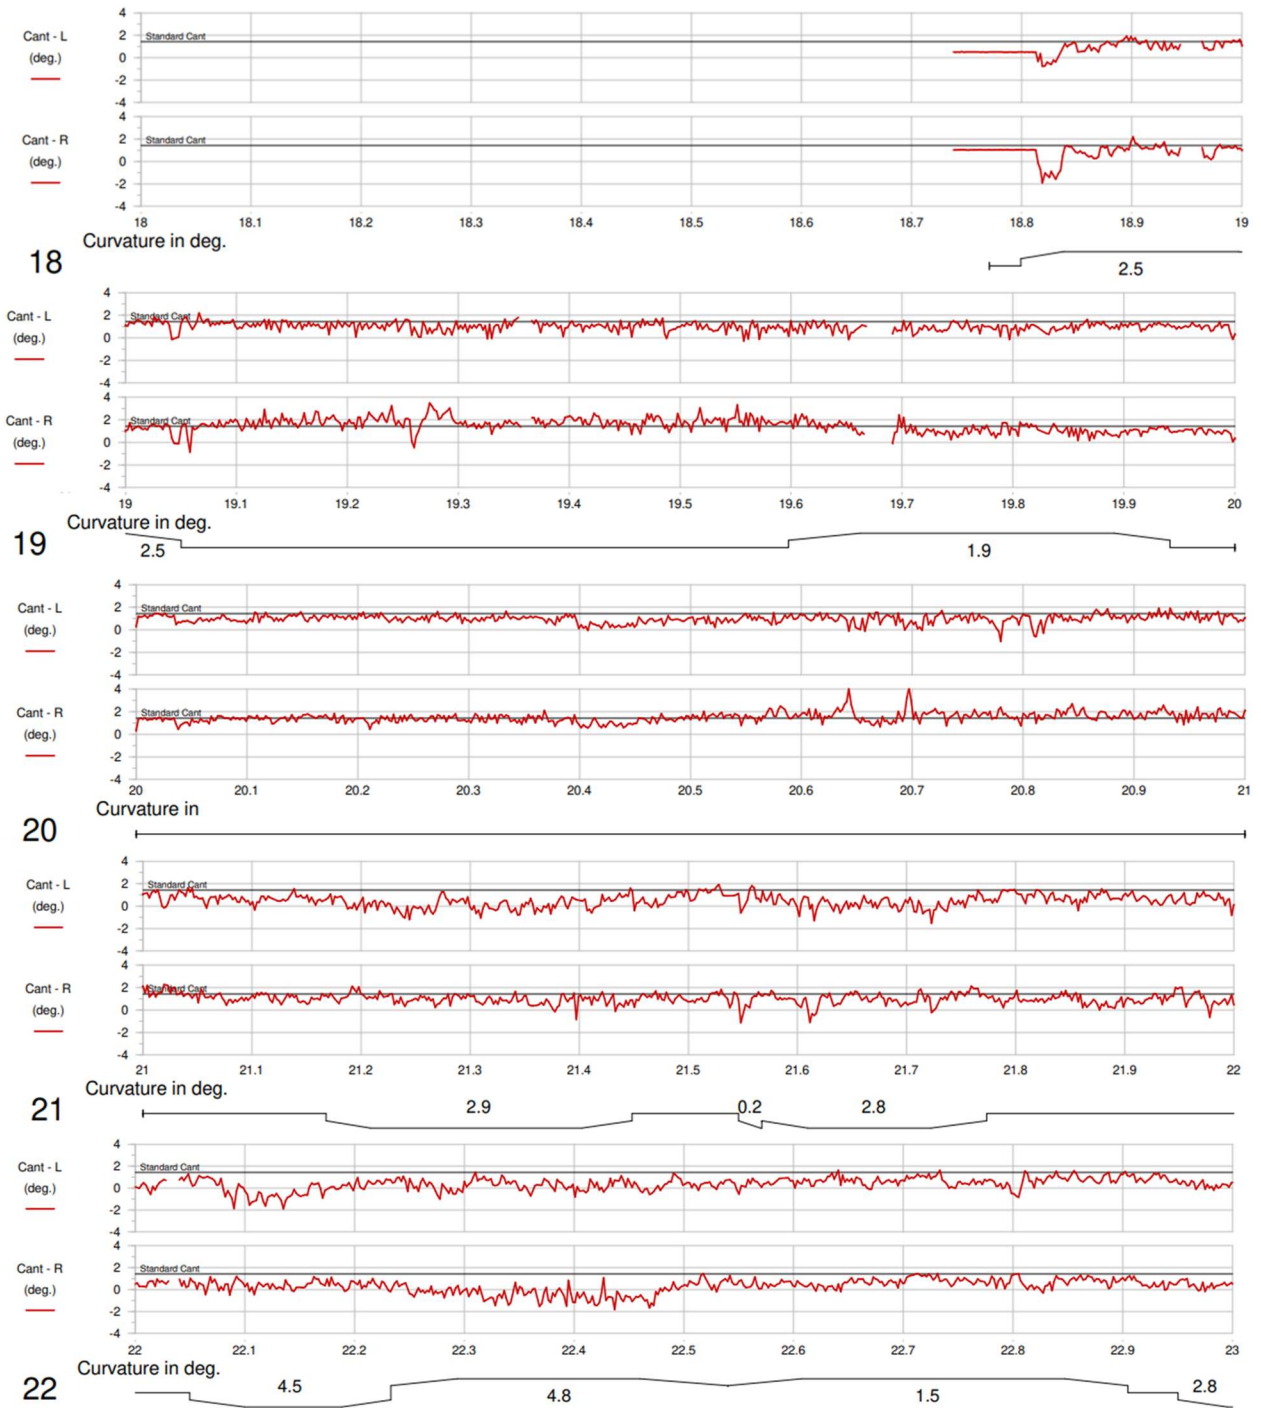
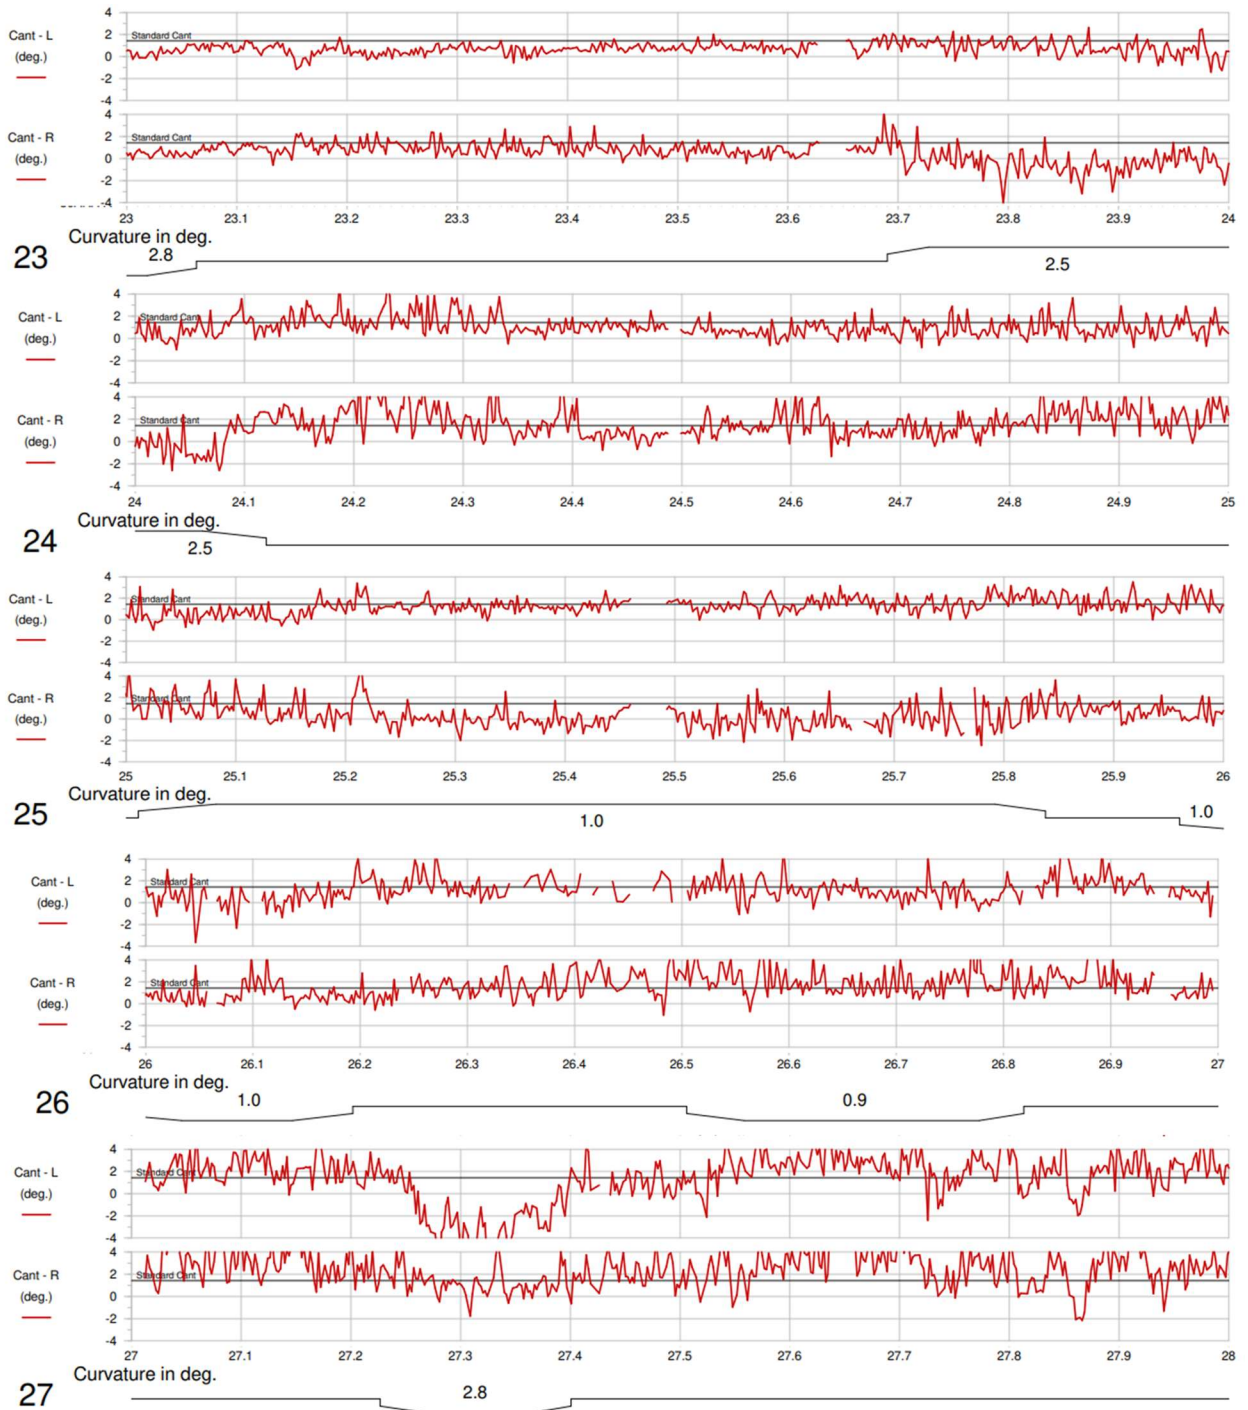
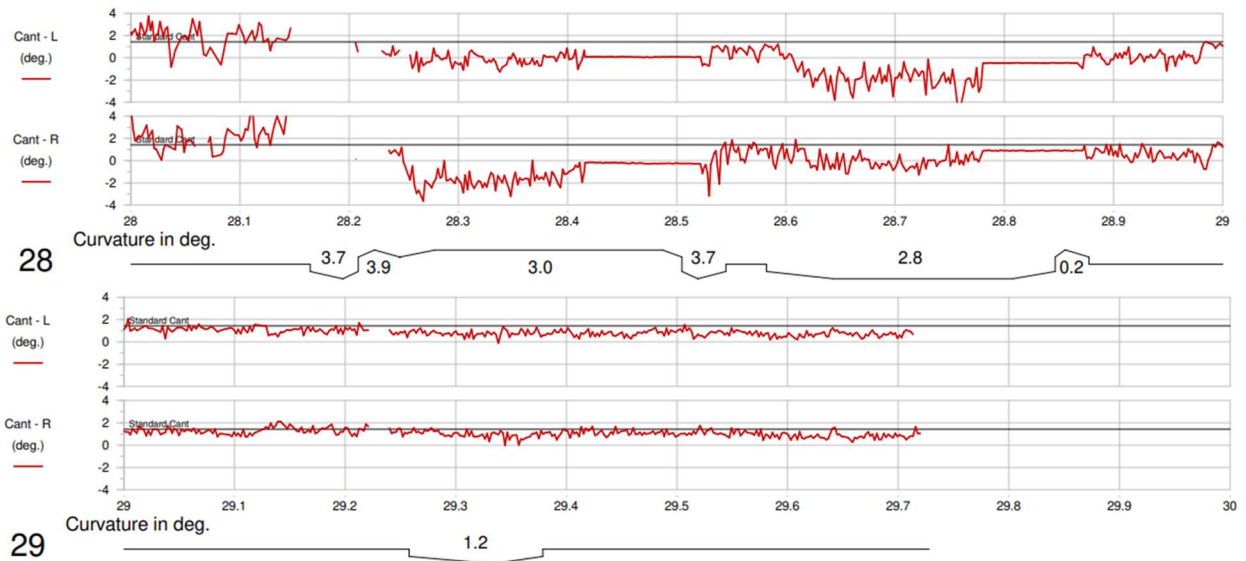
**CANT Findings:** The data from the October 11, 2023 Geometry Car inspection report indicates a significant variation in roll as a train traverses northward towards the Richland customer base. While unfavorable tie conditions are prevalent throughout the rail infrastructure, the cant (roll) is the most subuded over the section of track that has been upgraded to 136 lb rail and north of the wye headed to Horn Rapids Road. The inherent strength of the stronger rail clearly is helping to reduce a portion of the cant variation. On the upper end of the POB's track, conditions are much drier given an elevated roadbed which aids with water runoff and reduced mud buildup. Starting with the shift to 90 lb. rail near Duportail Street combined with the highest concentration of defective and marginal / fair ties, further helps to support the anecdotal Van Giesen is the worst area of all per Class 1's operations feedback of the train consist shifting side to side while traversing the mainline track.

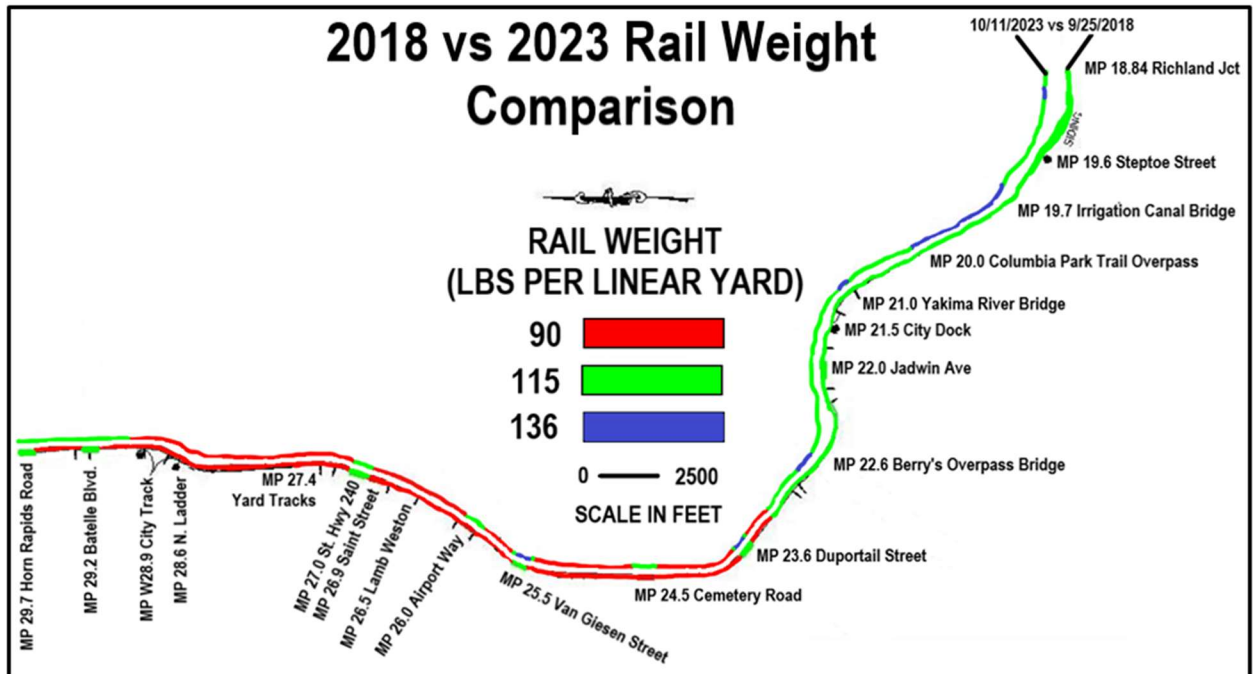
Exhibit D.22

**Findings:** The data indicates that over the last five years, four crossings have seen the pre-existing 115 lb. rail be replaced with a much stronger 136 lb rail. Additionally, 1.48 miles of 115 lb. rail has been replaced with 136 lb. rail between MP 19.71 and MP 20.19.

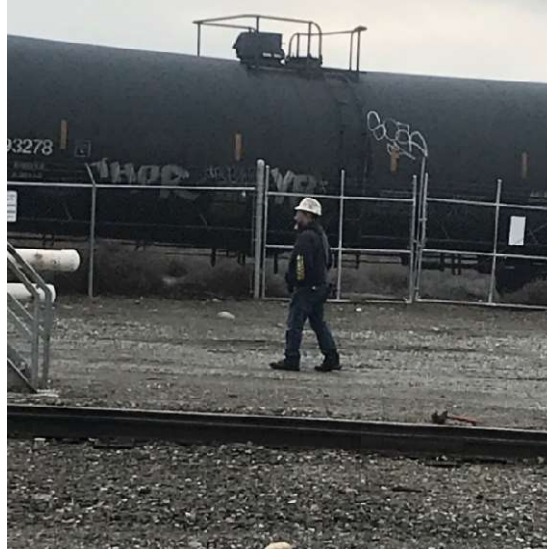
**Exhibit E.3**

- 1) Despite being an Order In rail customer whereby providing spotting instructions to the Class I's, historic issues with tank cars being incorrectly spotted have plagued the facility. To address these car spotting problems driven by inbound commodity differences, Lamb Weston has assigned an operator to monitor the entire time rail cars are being switched to ensure work is being done correctly by the Class I crews.

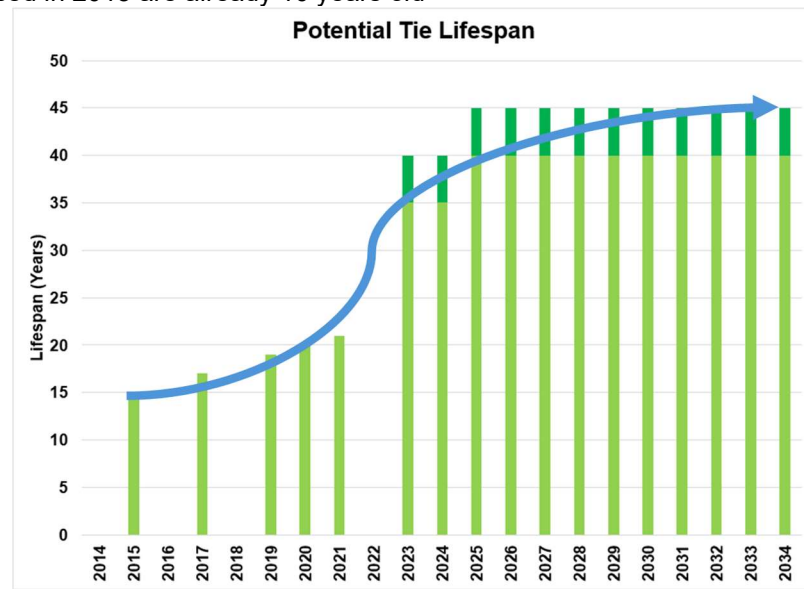
**Exhibit H.25**

In conclusion, it is necessary to call out some negative impacts to newly replaced railroad ties over the last decade. Mid to late 2010's tie installations, will have a shortened lifespan compared to future tie replacements due to:

- historical uneven weight distribution w/ adjacent ties
- impact from pre-existing poor ballast conditions
- ties replaced in 2015 are already 10 years old

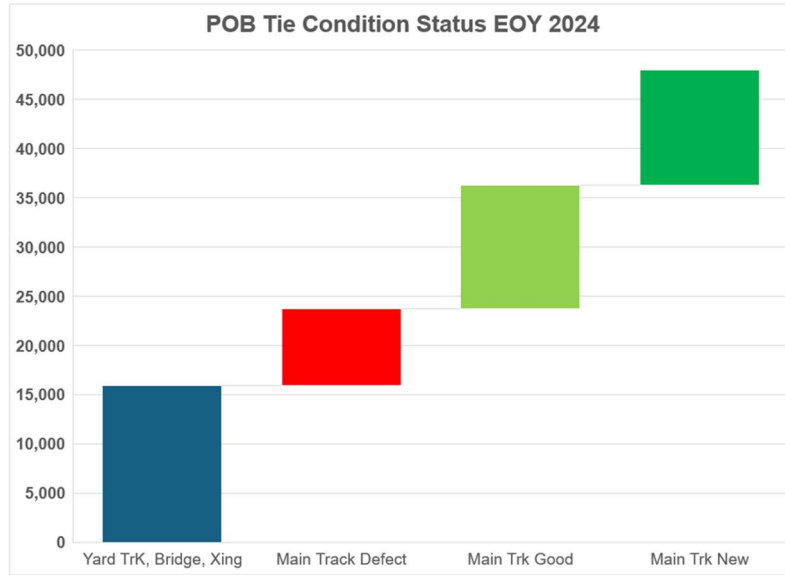
**Exhibit H.26**

On the flip side, railroad ties that were replaced during 2023 tie replacement work and the upcoming 2024 project and maintenance work, will equate to on average 2 of every 3 ties on the main track being good or

better. Having this improved infrastructure combined with a recurring undercutting program, should result in 2023, 2024, and future replacement ties experiencing a much longer (33+%) lifespan than current.
