Existing Conditions Study Report

RICHLAND, WA

JULY 20<sup>TH</sup>, 2023

# STRUCTURAL EVALUATION REPORT

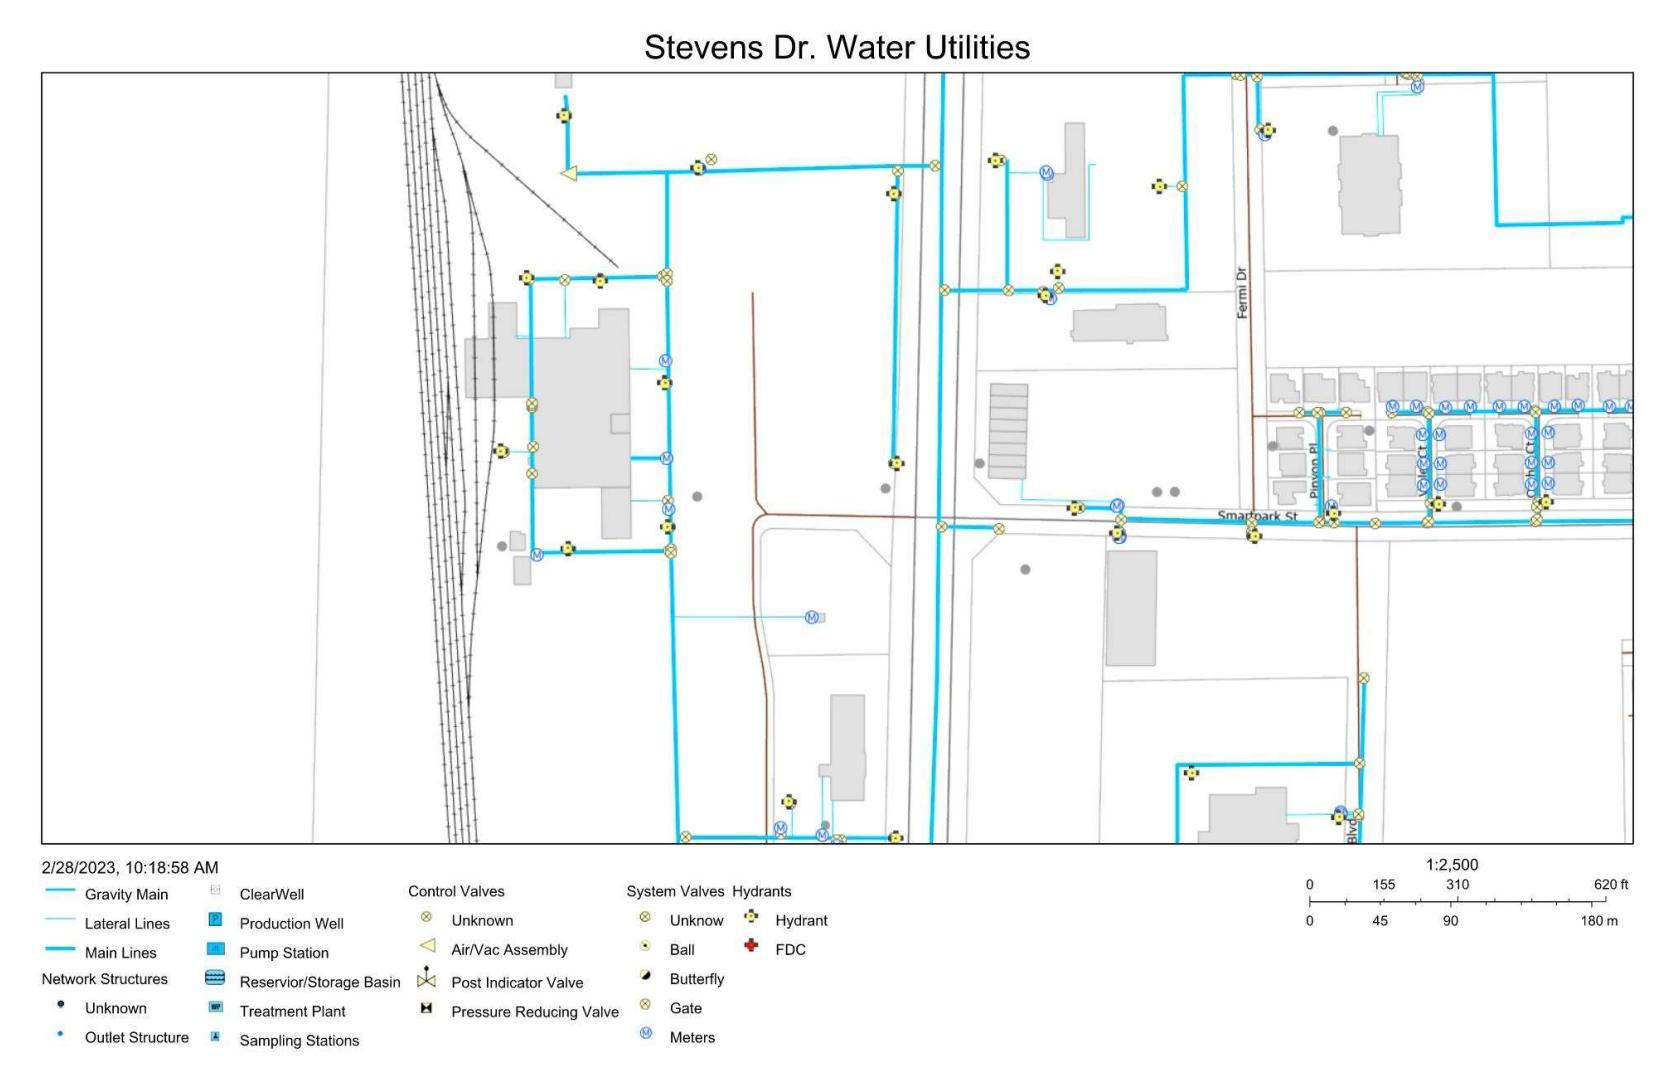
## **APPENDIX A: WATER UTILITIES**

Note that PVC is not a typical water main material but is allowed. City of Richland GIS notes these mains as being PVC. If connection to or extension of the existing mains is proposed, further site investigation (via pothole) is recommended.

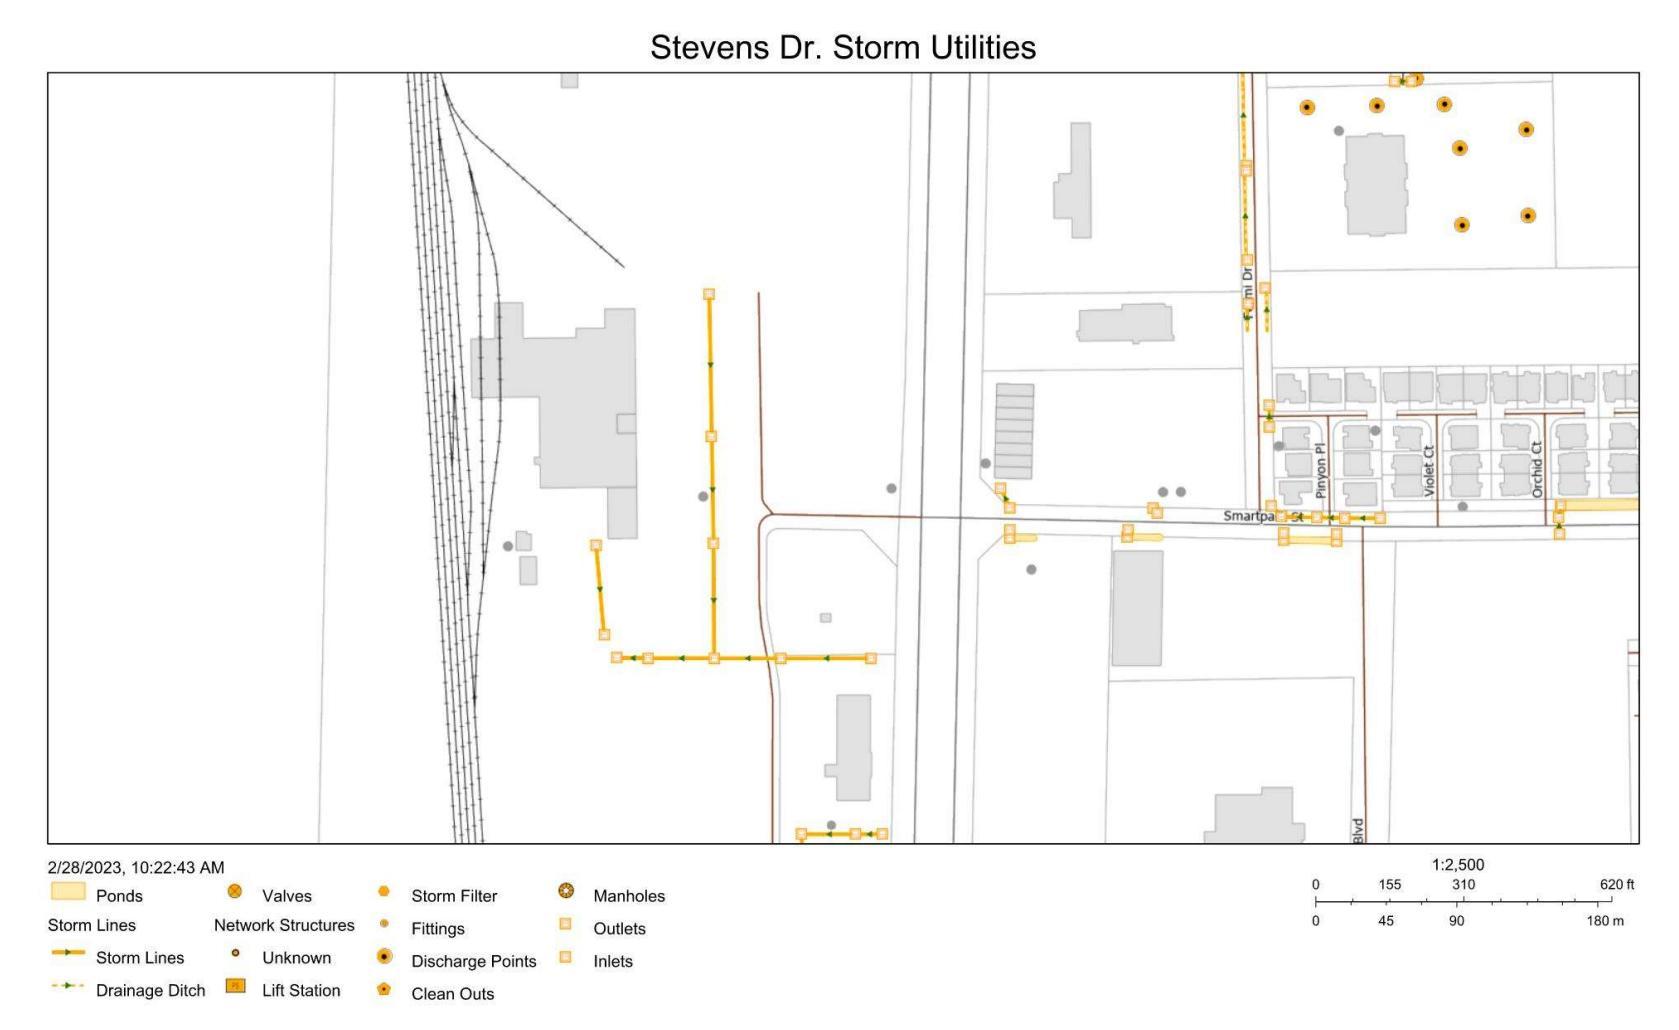
## **APPENDIX C: STORMWATER UTILITIES**

KPFF reviewed satellite imagery, GIS information from the City of Richland and Benton County, and corresponded with Pam Everham, City of Richland Public Works. This information all showed that none of the on-site stormwater system is connected to an off-site stormwater system. Based on this information, in appears the on-stie stormwater system connects to an infiltration facility. Additional research and information will be needed to confirm stormwater infiltration and conveyance. See Appendix C for a map showing existing stormwater main locations.

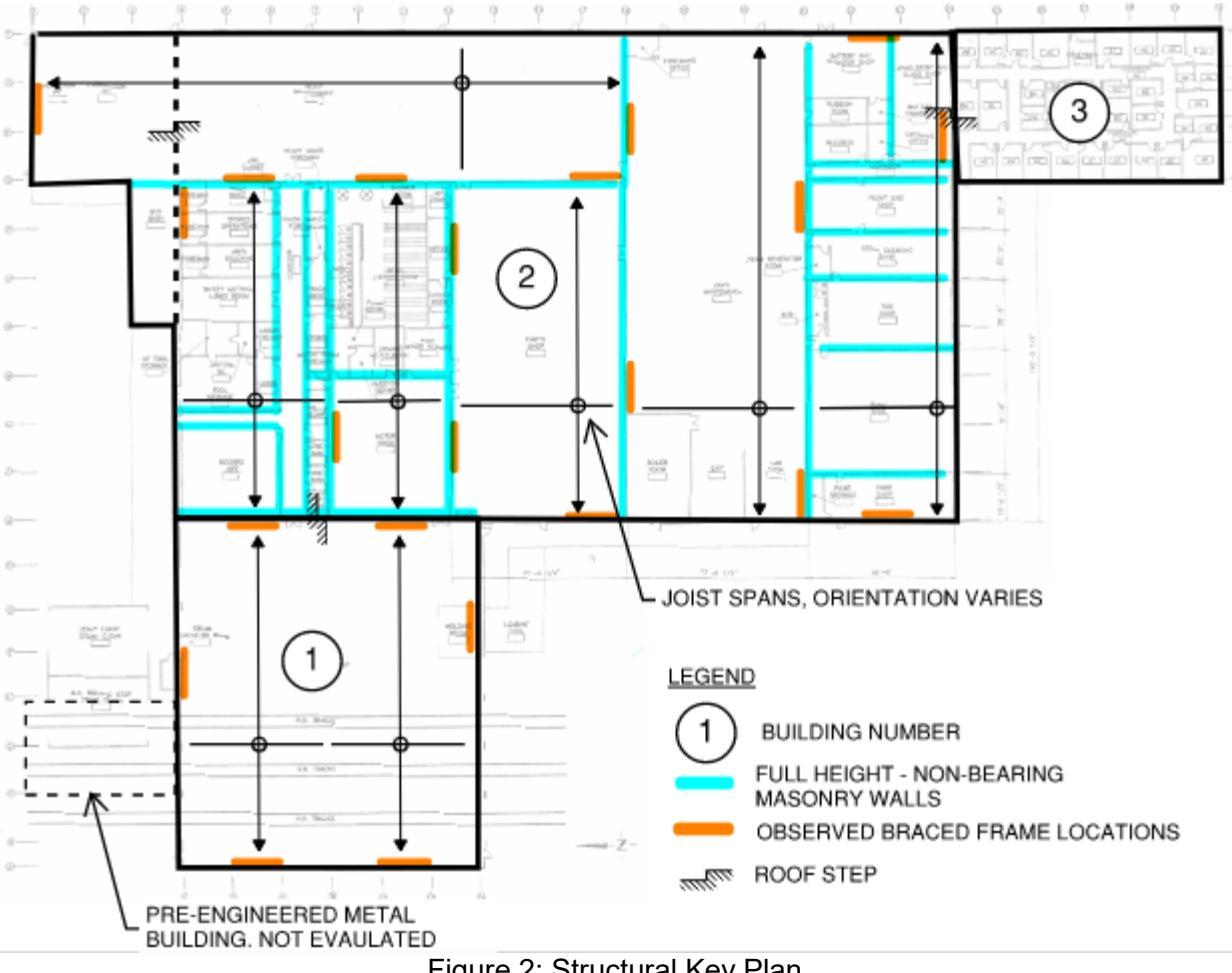
Figure 2: Structural Key Plan

Structural drawings for the existing facility are unavailable; however, there is one architectural plan sheet produced on November 8, 2001 showing interior space layout and rough building dimensions. The building is comprised of (3) independent variable height single-story flat-roof structures of similar construction (see Figure 2 below).

Zone 3 is a shorter office building with concealed structure. The structure is presumed to consist of wood roof framing and steel post and beam construction.

Based on the building structural observations, code review, condition assessment, and follow up discussions between relevant parties KPFF offers the following recommendations as the team advances development of the project. Recommendations are limited to zones 1 and 2 as shown in Figure 2 unless noted otherwise. It is KPFF's understanding that the Port of Benton would like to avoid structural upgrades in order to preserve funding for higher priority items unless there are glaring deficiencies or if they are required by code.
